Architectural Tiles: Conservation and Restoration

**From the Medieval Period to
the Twentieth Century**

Lesley Durbin BA(Hons) Dip Eur Hum. PACR

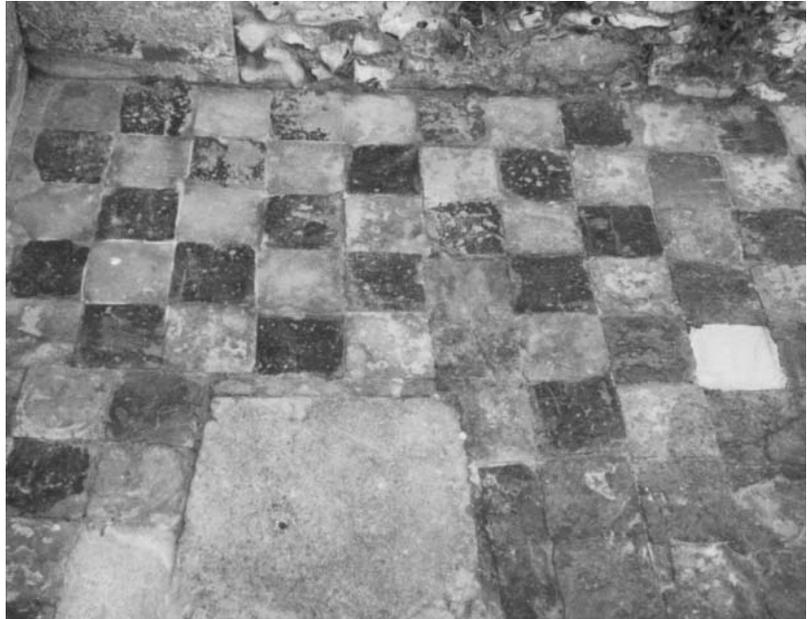
Figure 1.5
Chequerboard format found at
Thetford Abbey, Norfolk.

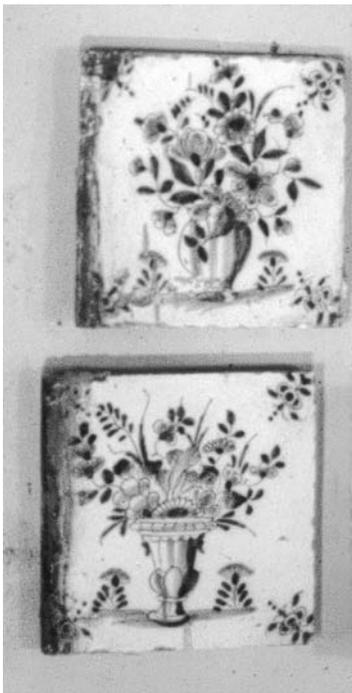
Figure 2.10
Showing loss of glaze fragments from the edges of the tile, also the extent of soot absorption from use in a fireplace.

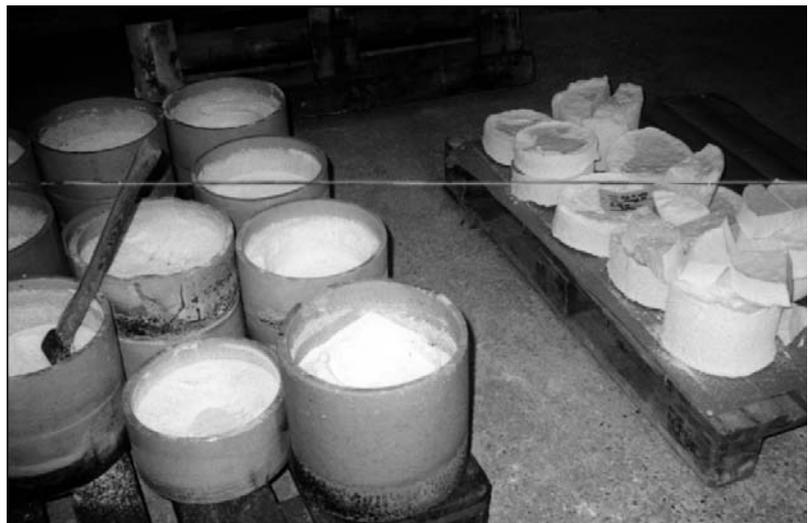
Figure 2.13
Glaze process showing melded glaze in block form.

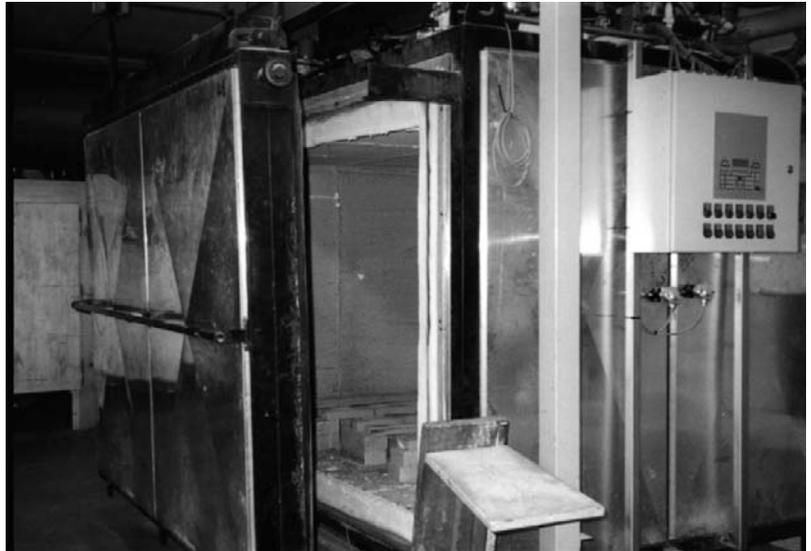
Figure 2.14
Gas fired kiln for biscuit tiles.

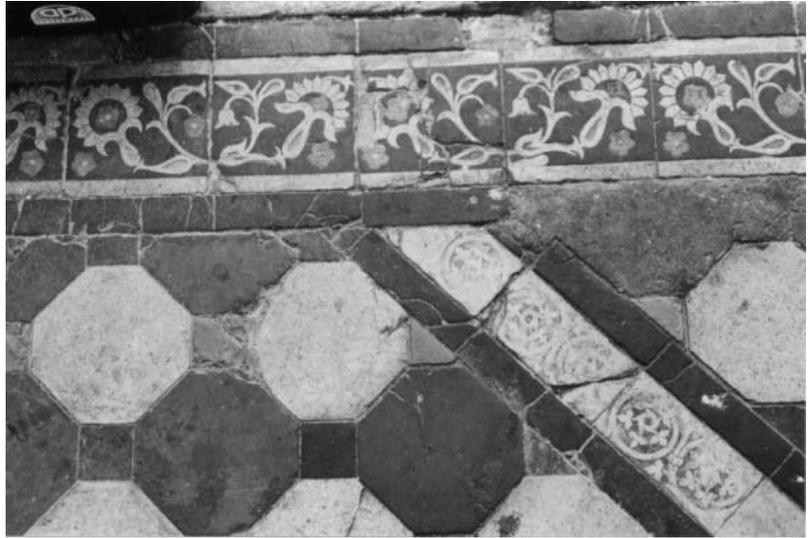
**Figure 2.23**

Surface wear to a group of encaustic tiles.

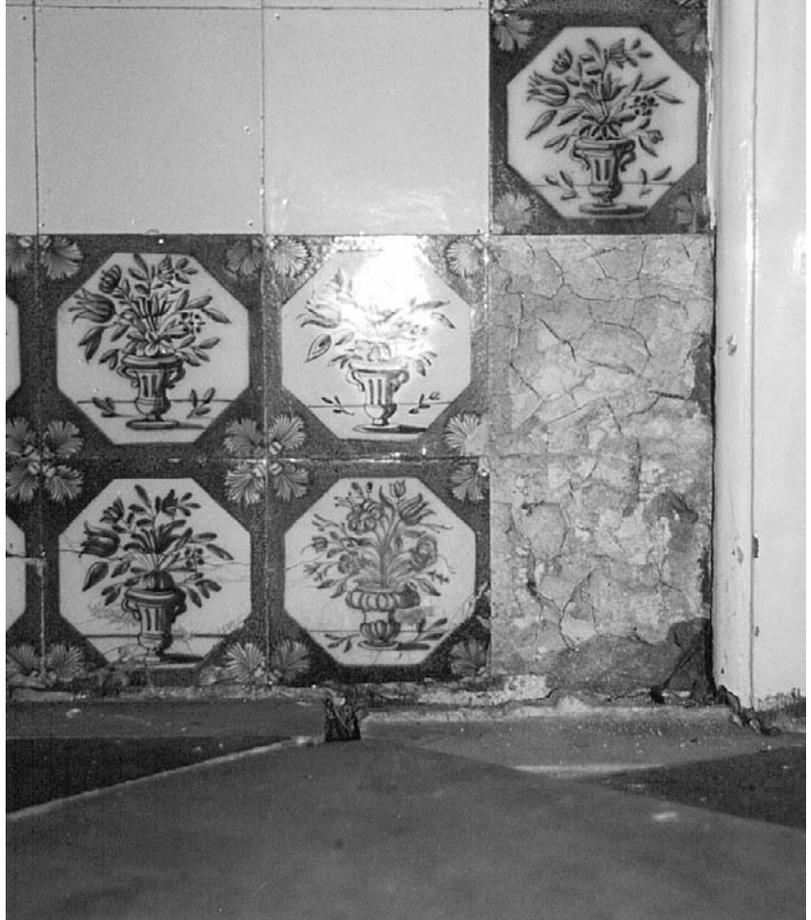
Figure 3.11
Eighteenth century mortar substrate,
Carshalton Water Tower, Surrey.

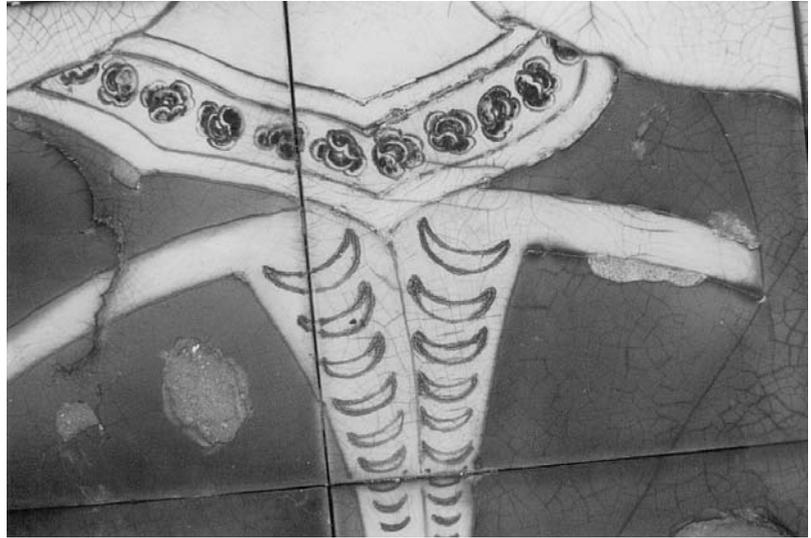
Figure 3.22
Delamination caused by frost penetration.

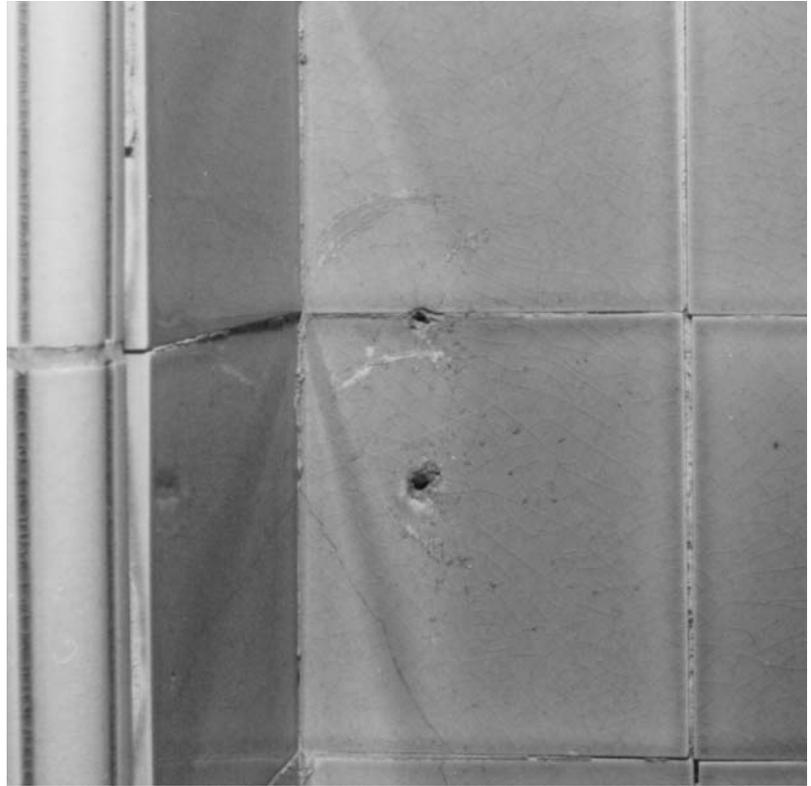
Figure 5.1
Typical damage caused by drilling
into glazed tiles.

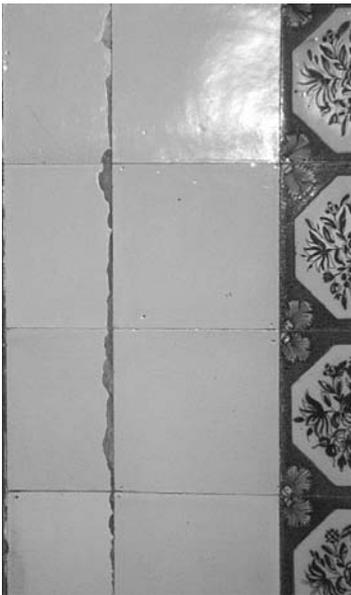
Figure 5.2
Typical damage to the glazed edges
of delft tiles.

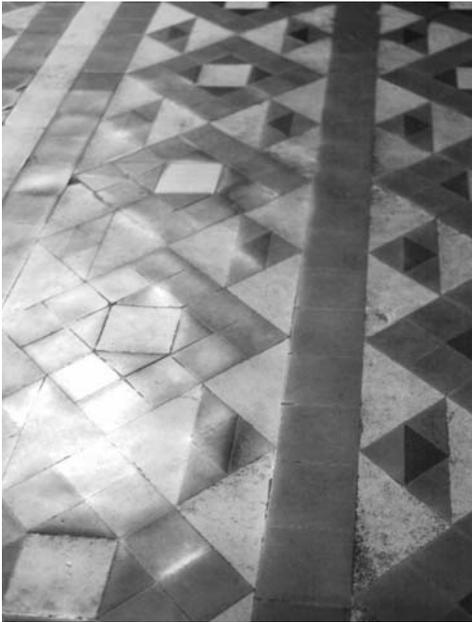
Figure 5.4
Typical damage caused by tread.

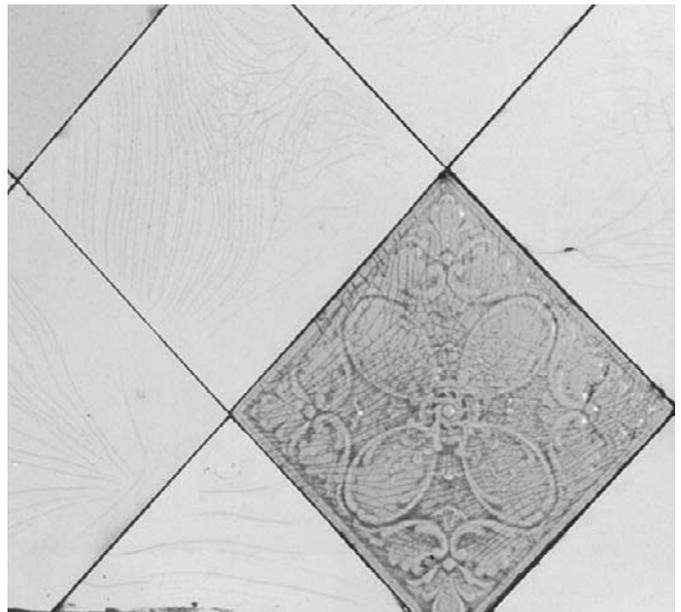
Figure 5.5
Typical crazing on old glazed tiles.

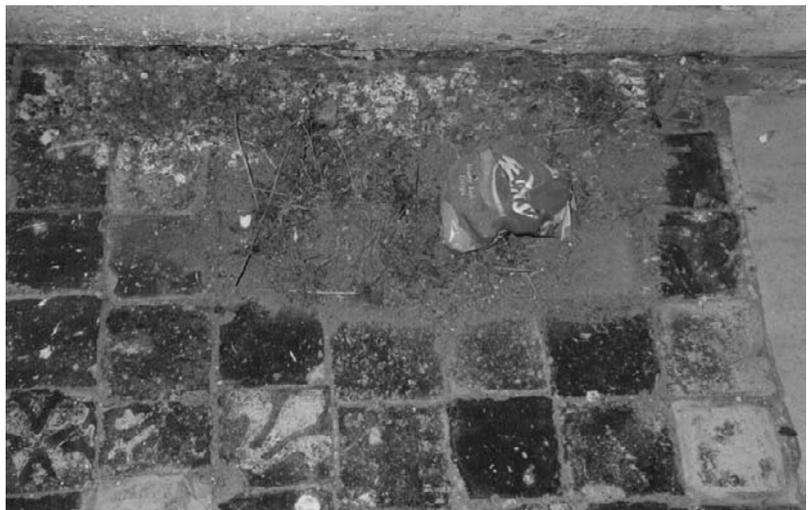
Figure 5.7
Debris on medieval tiles underneath a nest site.

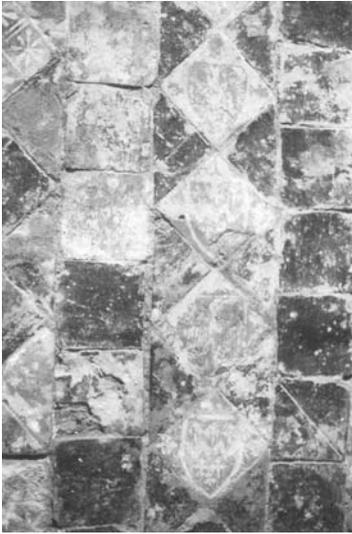
Figure 5.8
Lime encrustations on medieval tiles.

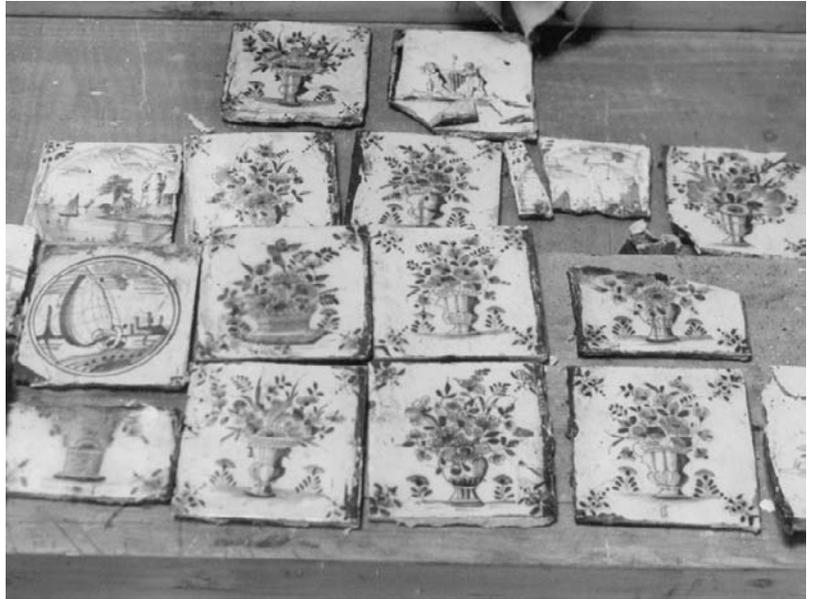
Figure 5.10
Delft tiles taken from a fireplace showing soot blackening of the edges.

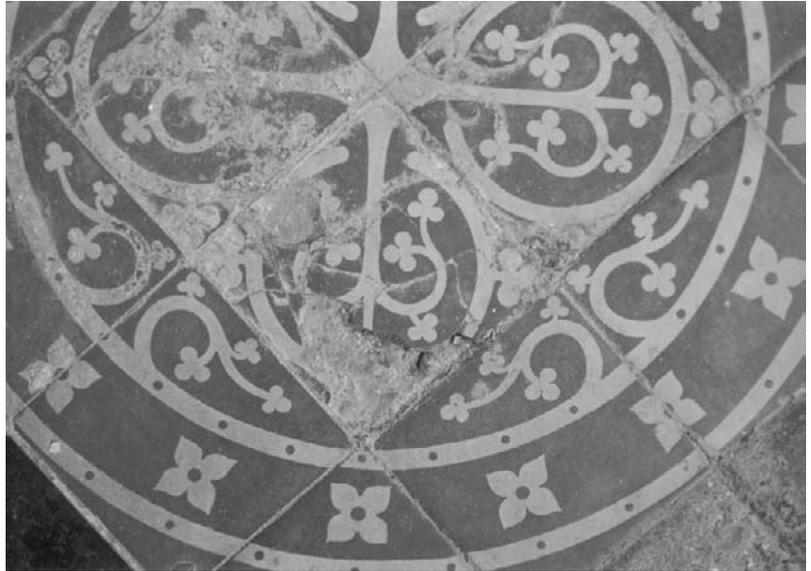
Figure 5.14
Salt damage to the surface of glazed tiles caused by constant leaching of water from above.

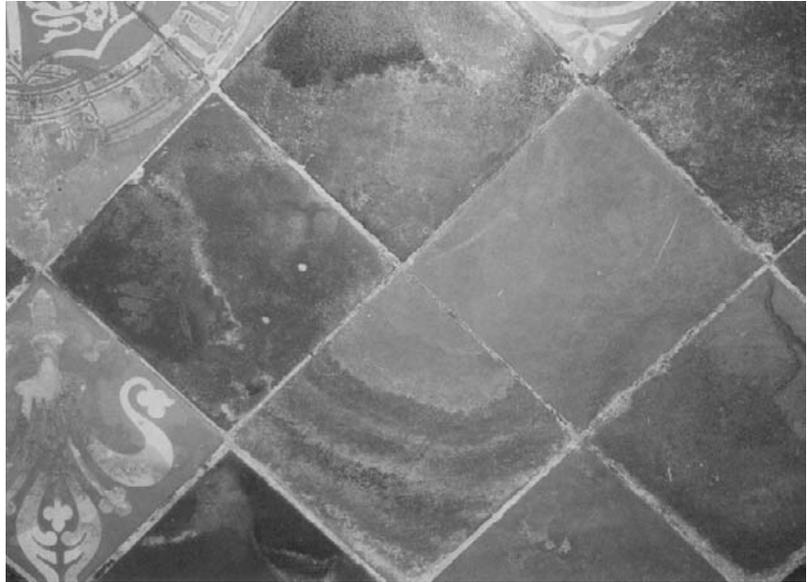
Figure 5.15
Residue of salt damage caused by
slow evaporation.

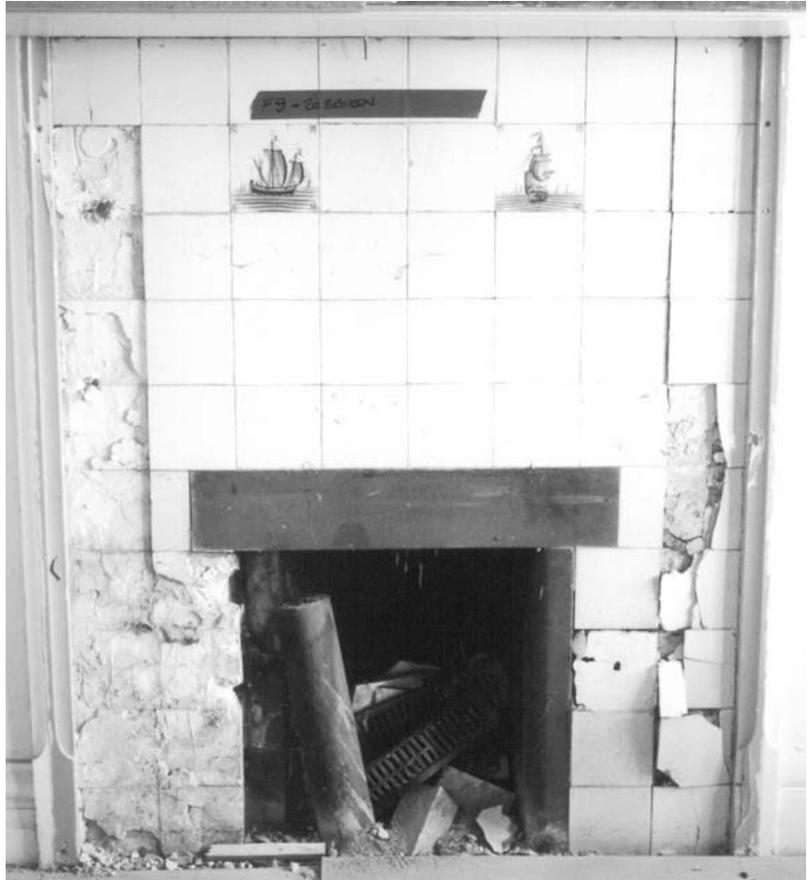
Figure 5.18
Degraded lime plaster adhesive in
a delft tile fireplace.

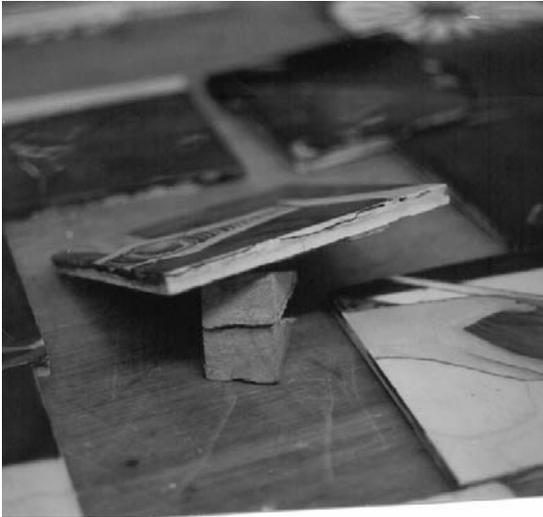
Figure 5.22
Delamination due to frost action.

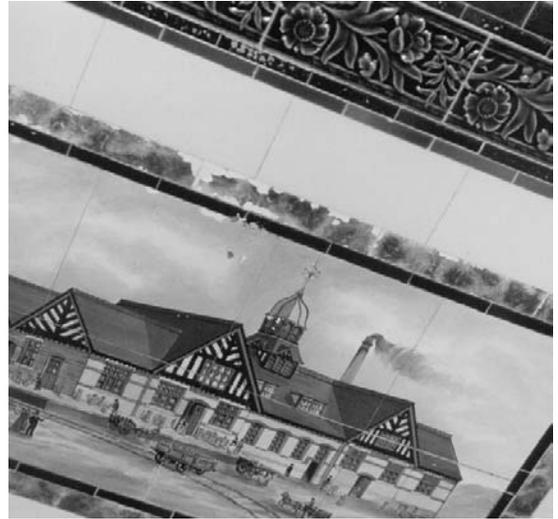
Figure 5.23
Spontaneous shedding of glaze due to tensile pressure.

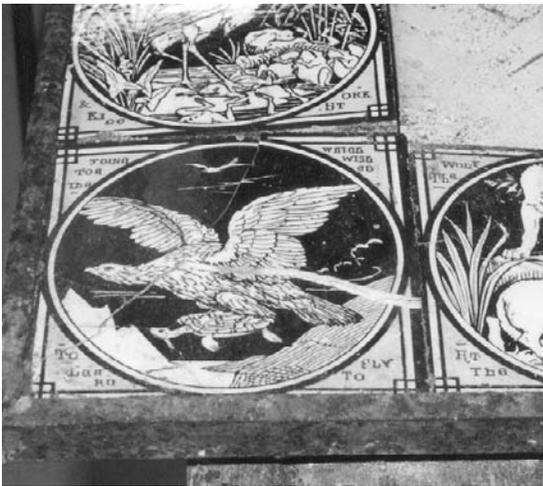
Figure 5.24
Fracturing caused by corrosion expansion.

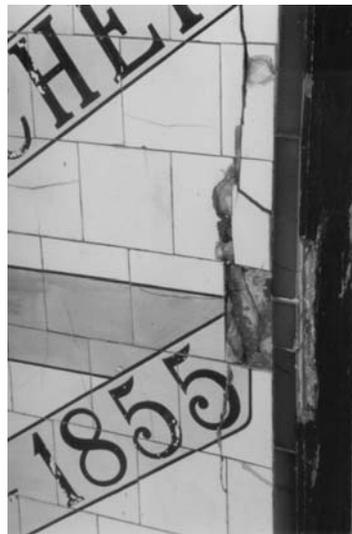
Figure 5.25
Compressive tension and shifting causing fracturing and misalignment.

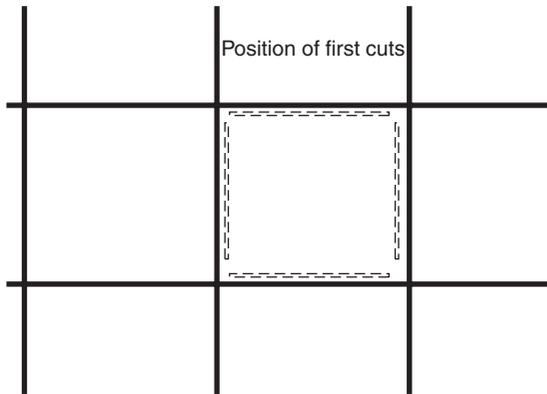
Figure 5.30
Diagram to illustrate removal of damaged historic tiles.

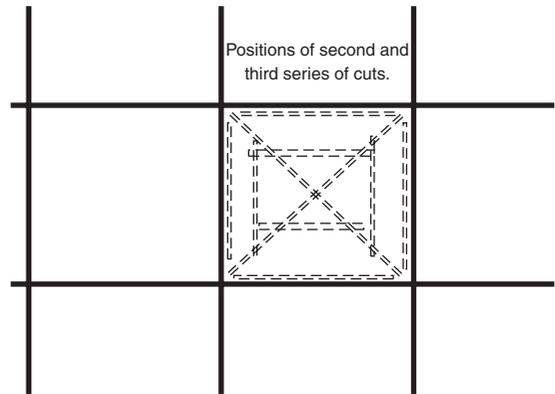
Figure 5.31
Diagram to illustrate removal of damaged historic tiles.

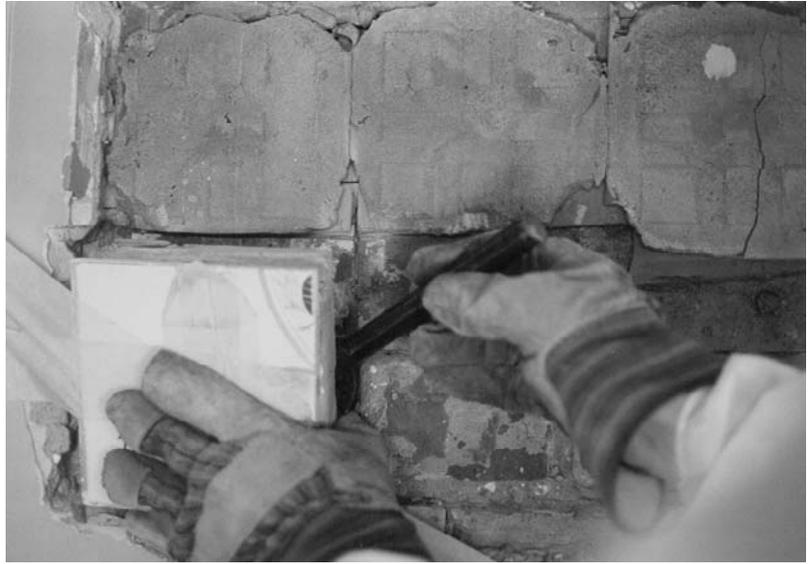
Figure 5.36
Releasing tiles from the substrate with mortar attached.

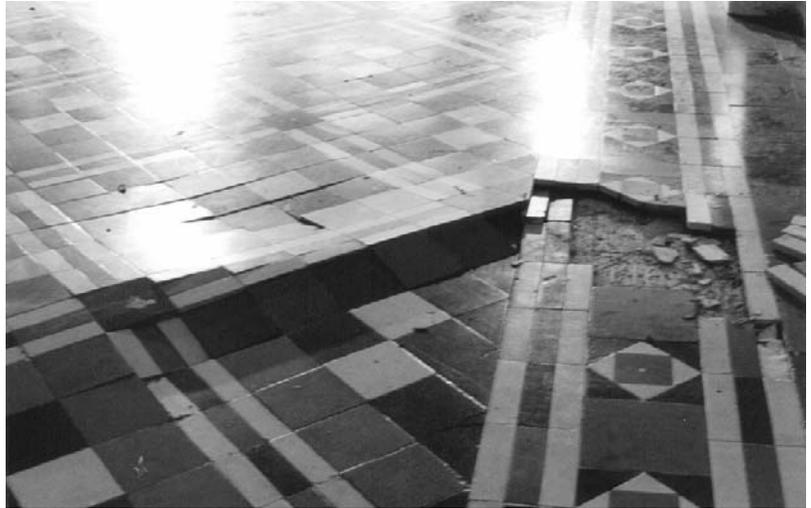
Figure 7.8
Differing sizes found in original tiling which had been cut to fit.

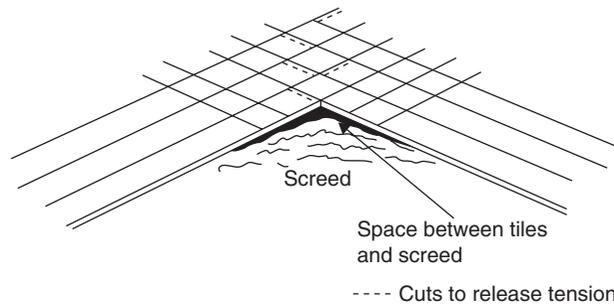
Figure 7.9
Diagram of the cuts used in the tile work under tension.

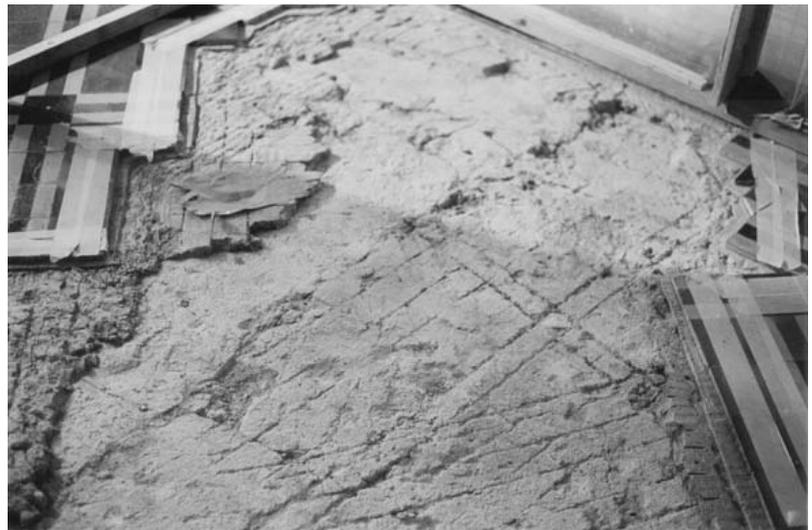
Figure 7.11
Fracturing in the lower screed.

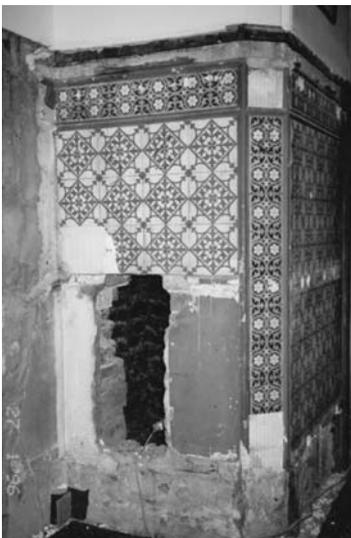
Figure 7.13
Damage to scheme caused by the letting in of heating ducts to walls.

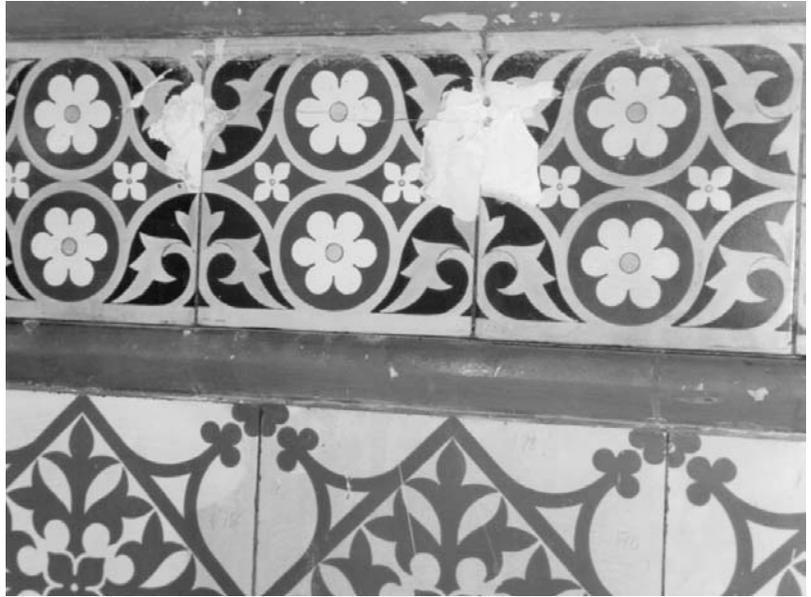
Figure 7.14
Damage caused by steel pins
hammered into tiles.

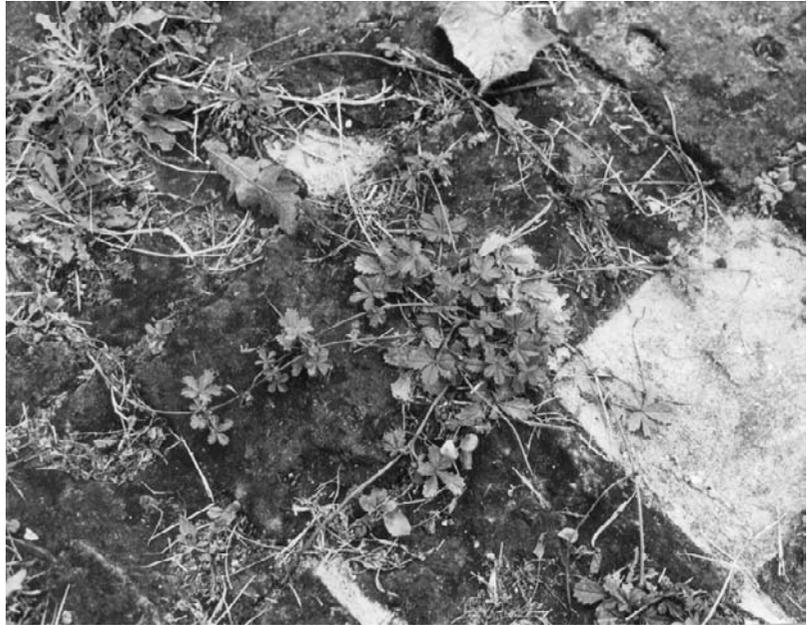
Figure 7.16
Damage caused by weed growth.

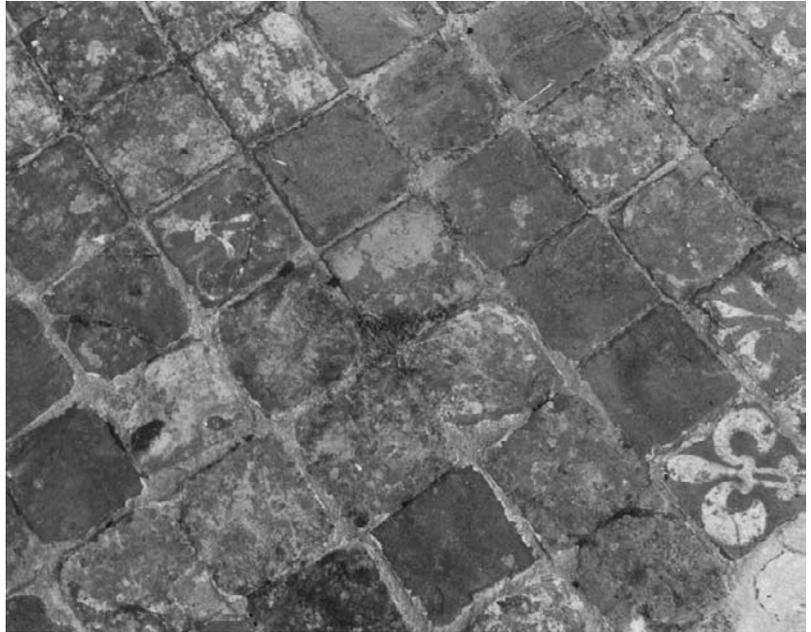
Figure 7.18
Lime mortar 'buffer' zone.

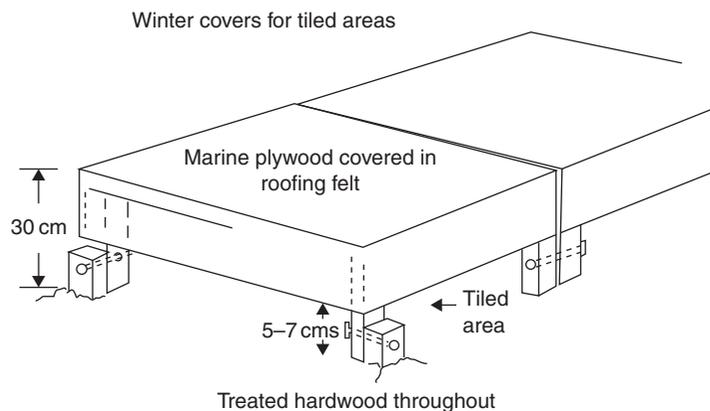
Figure 7.20
Diagram of winter covers.

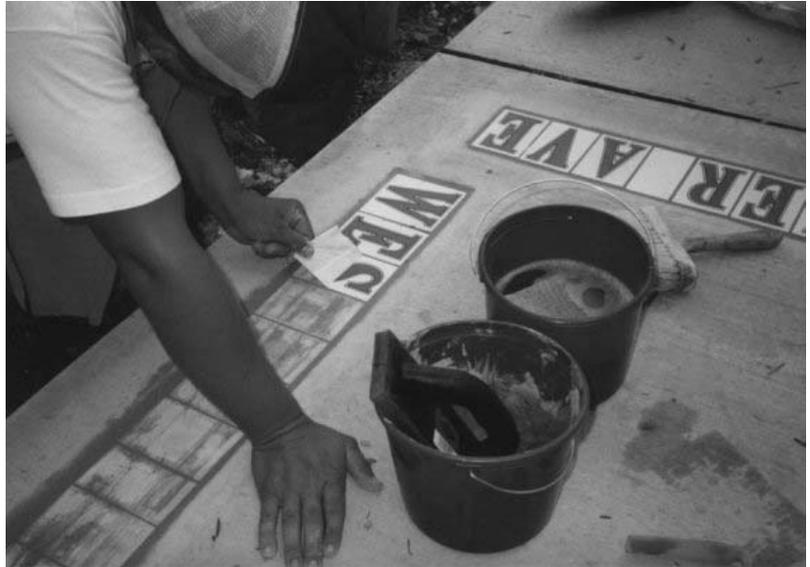
Figure 7.22
Grouting and removing protective tape from new tiles after installation.

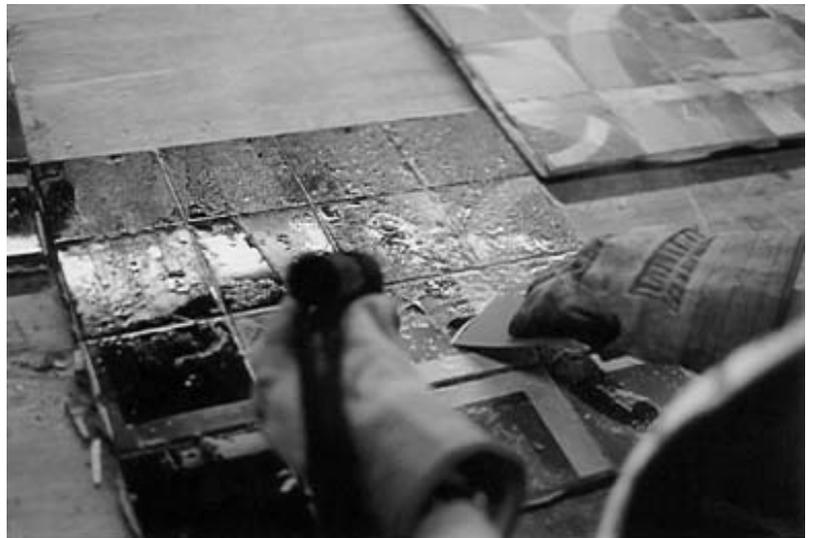
Figure 7.28
Removing the residue of adhesive with steam.
