Chemical Process Safety

Learning from
Case Histories

Third Edition

ROY E. SANDERS

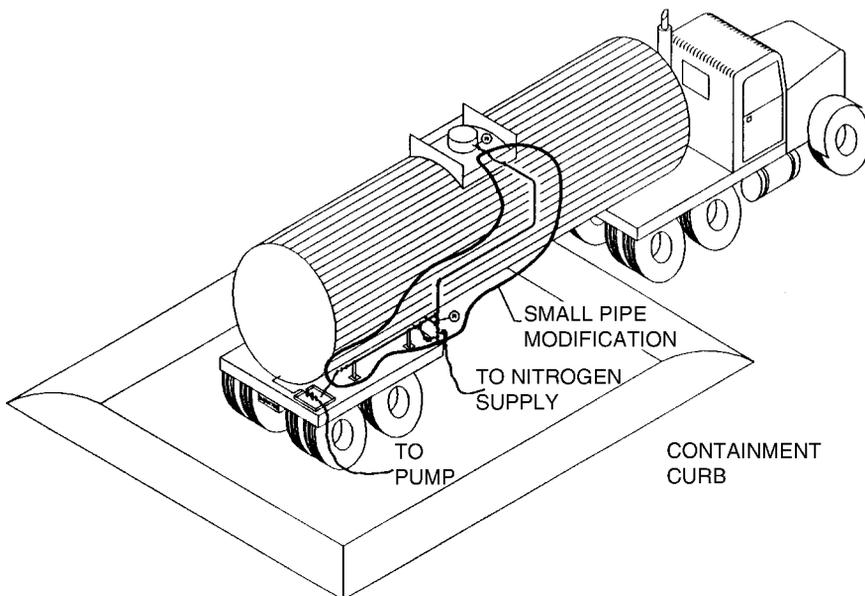
FIGURE 2–3 Tractor and tank truck ready to unload. Courtesy of Manuel David.

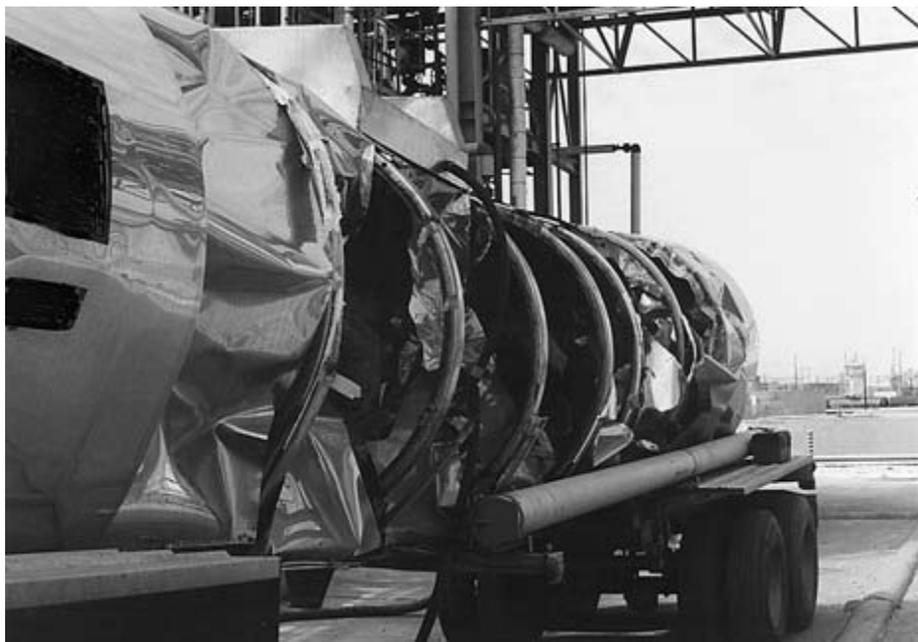
FIGURE 2-5 Close-up of tank failure and exposed ribs.

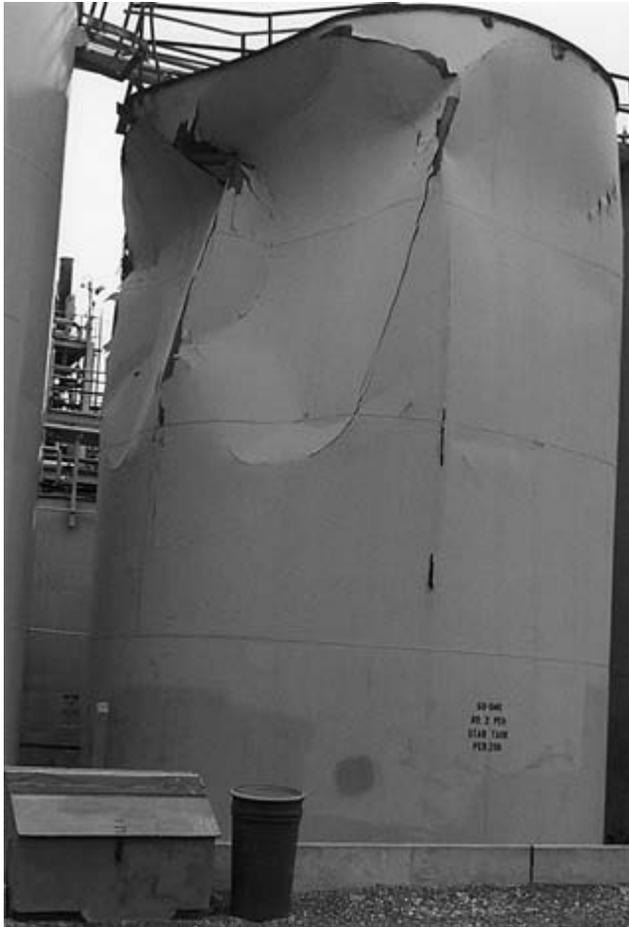
FIGURE 2-13 A 12-ft.-diameter tank ruined after vent system is improved.

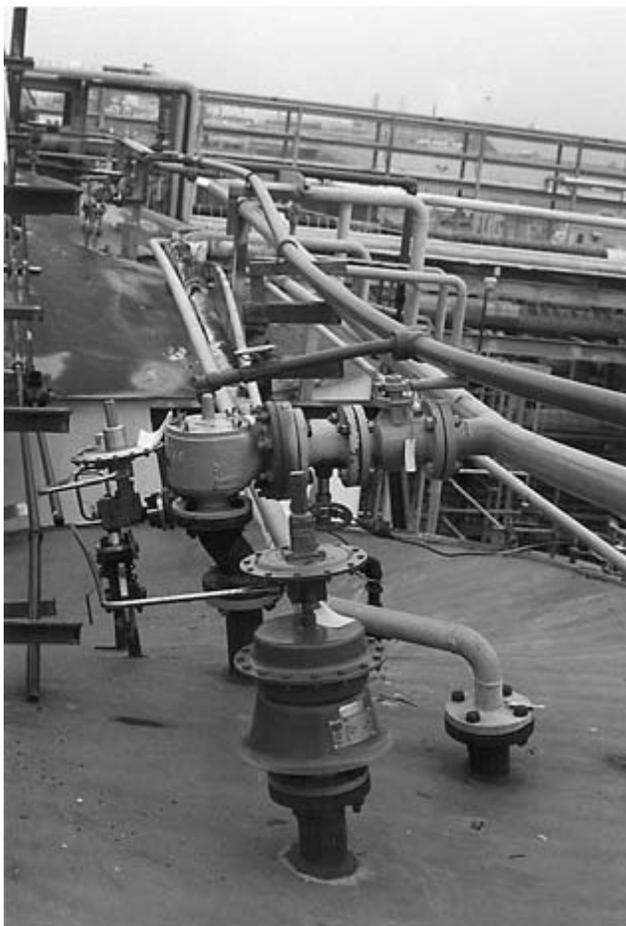
FIGURE 2-15 New but visually confusing piping system—after the incident.

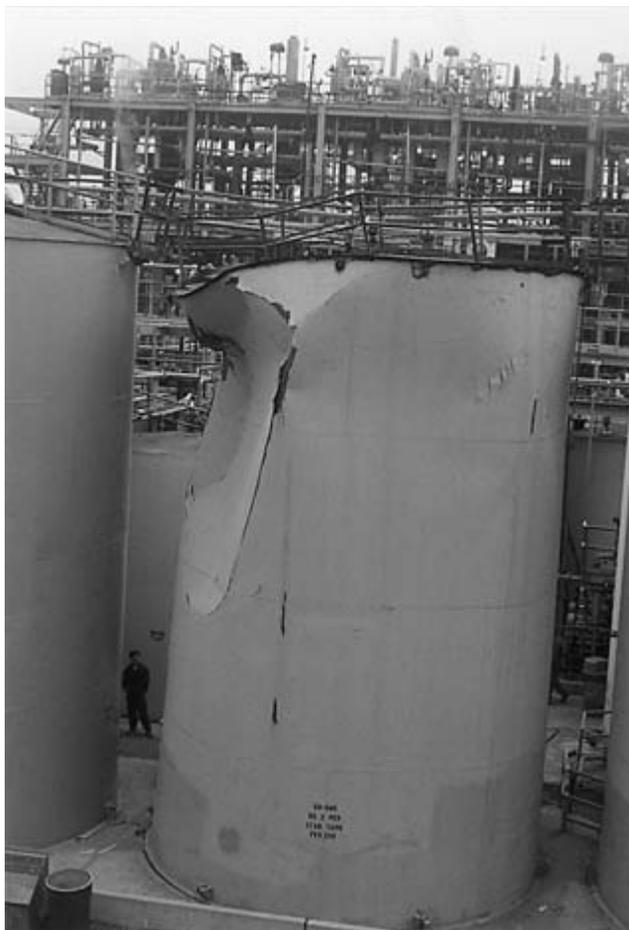
FIGURE 2-16 Crushed tank in the tank farm.

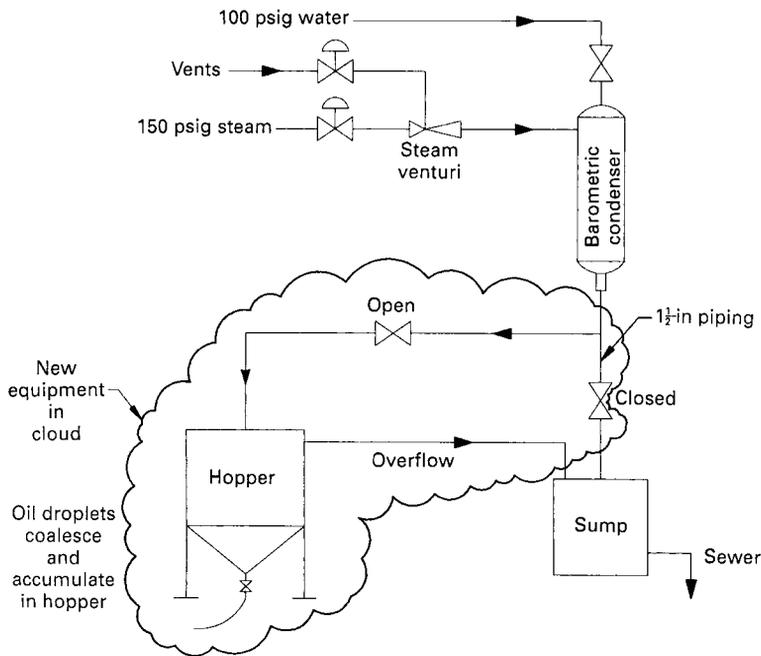
FIGURE 2–17 Modifications on water piping to reduce pollution potentials.
Courtesy of Jack M. Jarnagin.

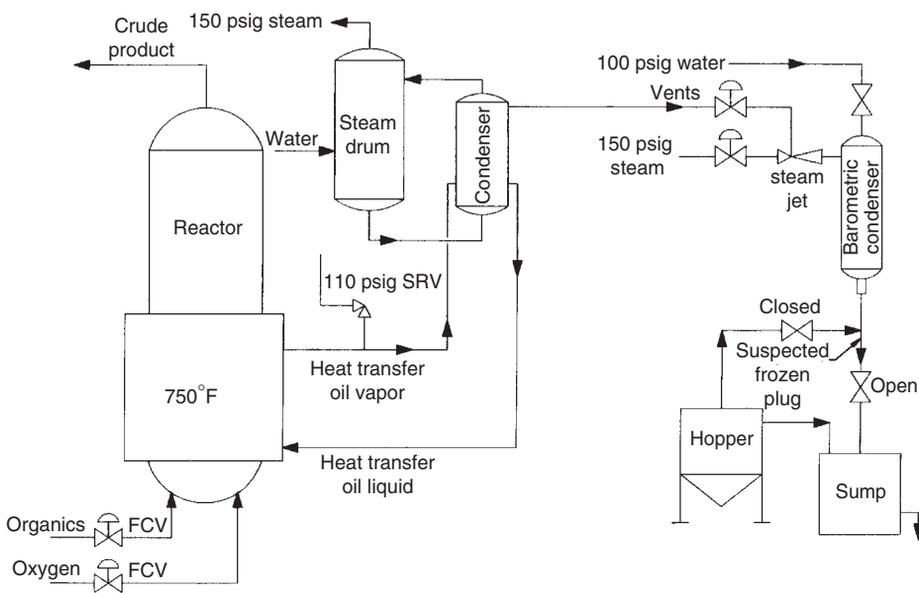
FIGURE 2–18 Solvents reactor system just before the explosion.
Courtesy of Jack M. Jarnagin.

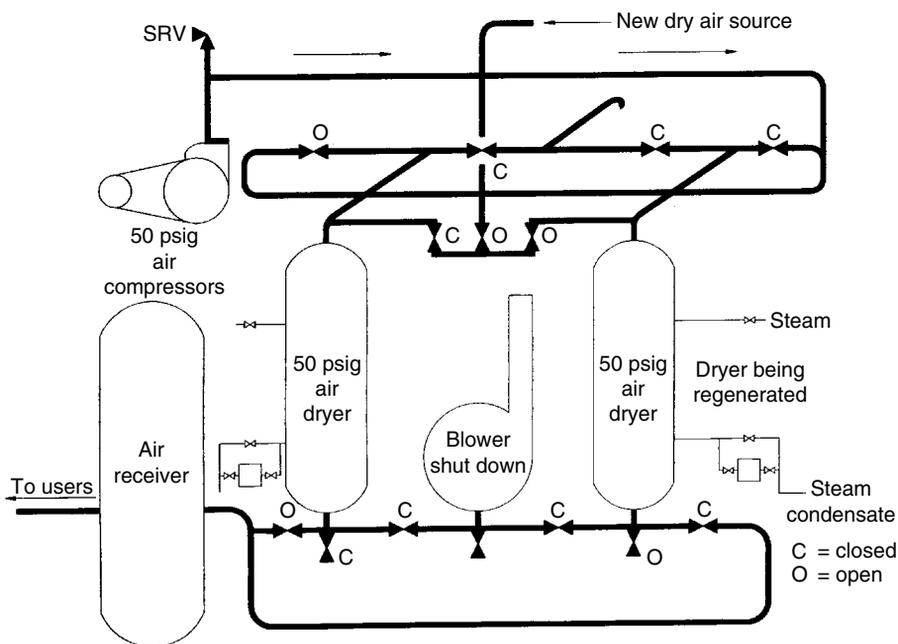
FIGURE 2-20 Modified dryer regeneration sequence at time of explosion.
Courtesy of J. M. Jarnagin.

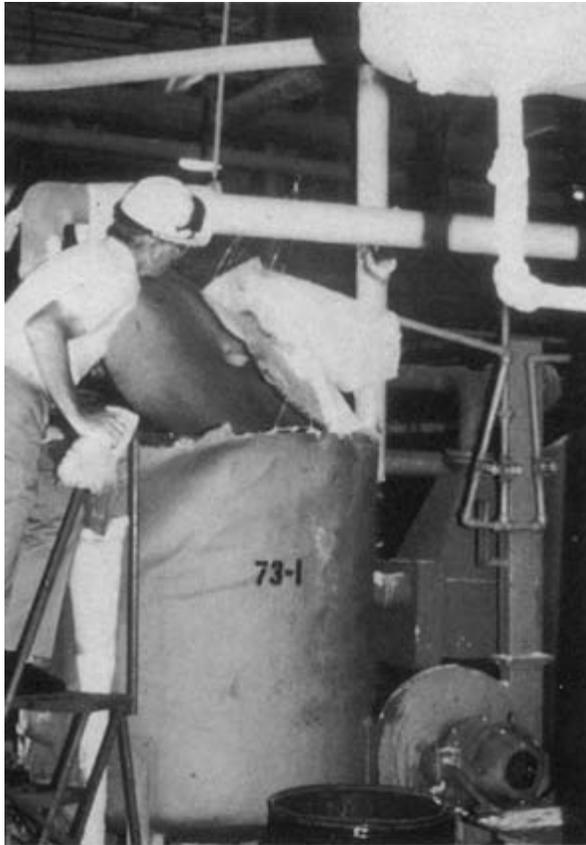
FIGURE 2-21 Employee examines the air dryer failure.

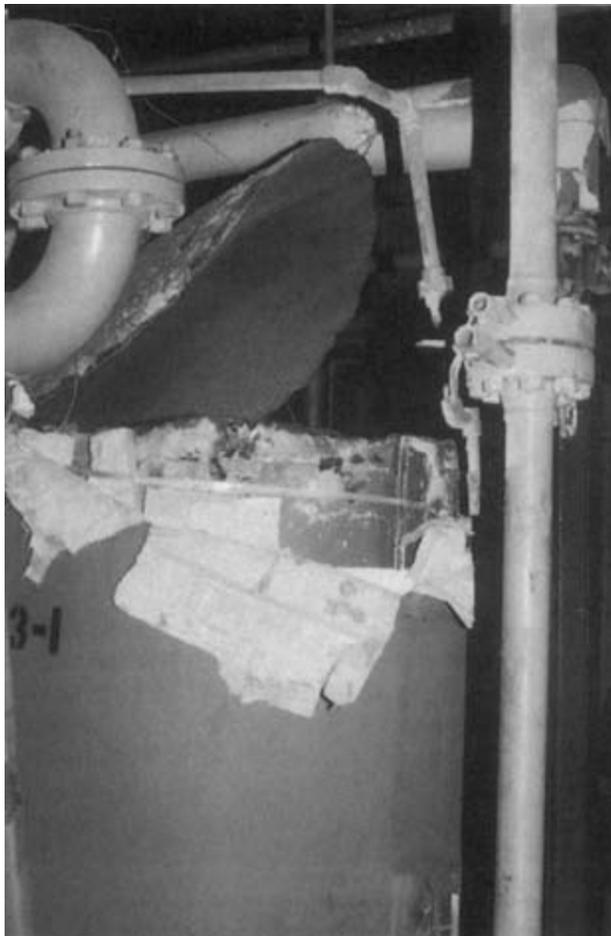
FIGURE 2-22 Close-up of the failed air dryer.

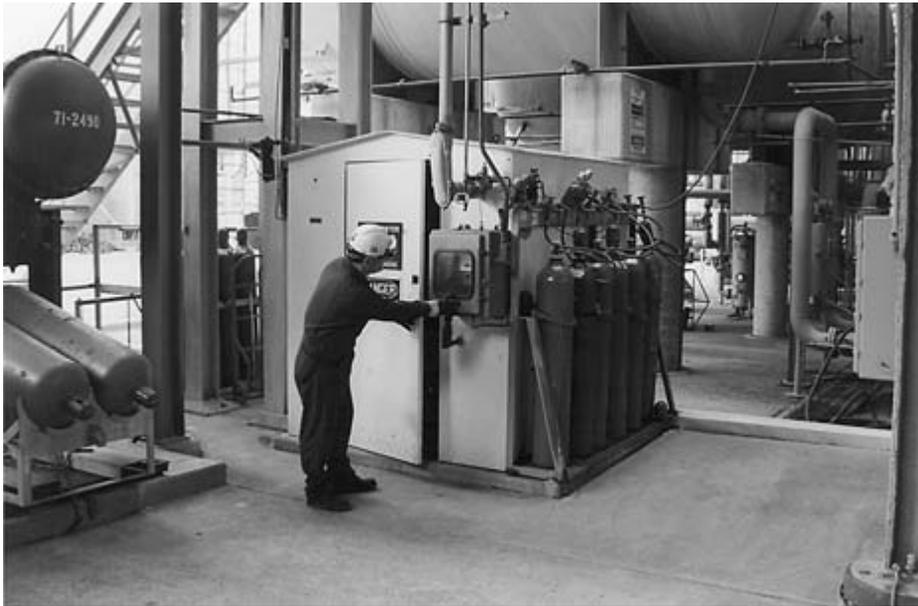
FIGURE 2–23 Typical pressurized and purged analyzer buildings found in chemical plants handling flammables.

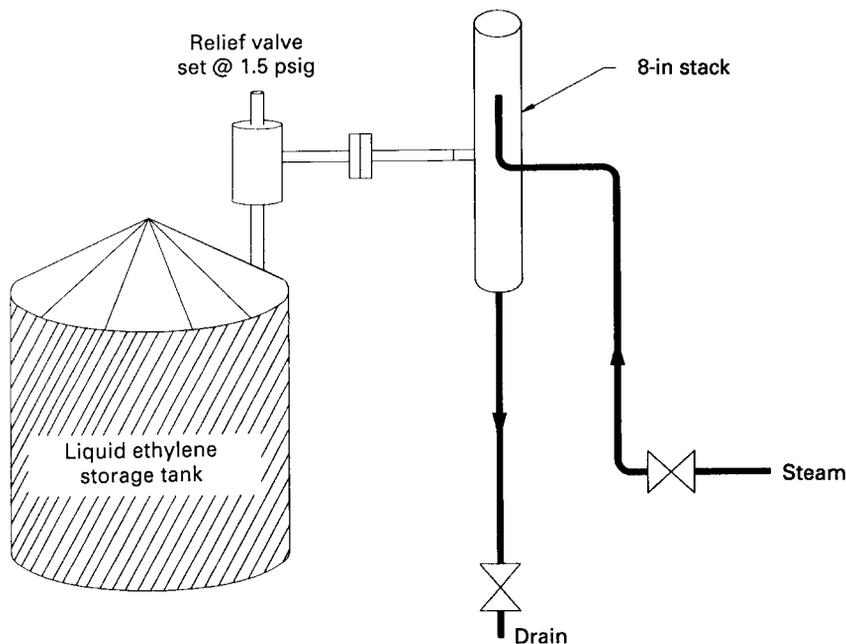
FIGURE 2–25 Well-intended vent modifications. Courtesy of T. A. Kletz.

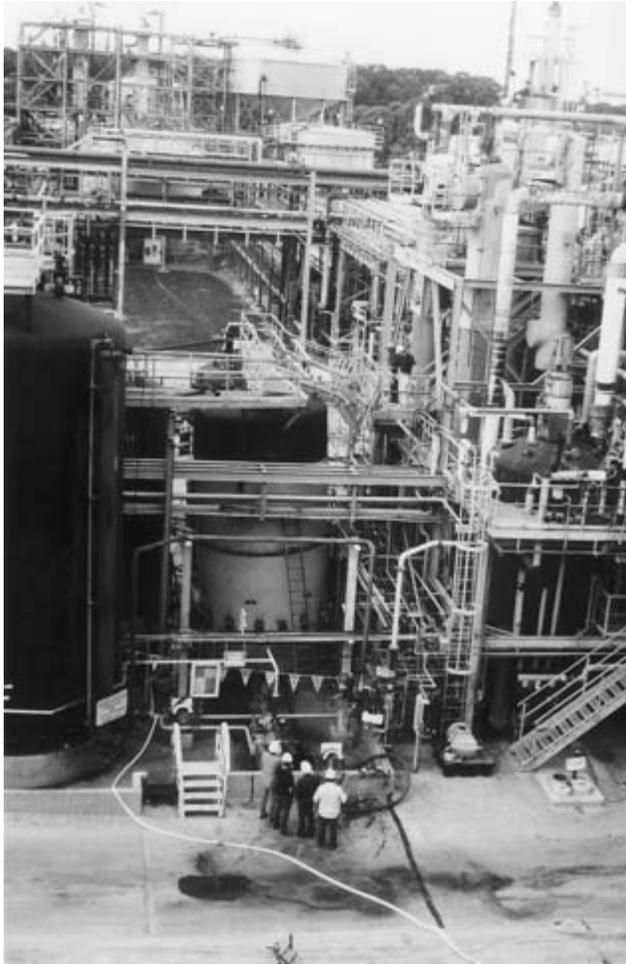
While preparing for the test, two mechanics blinded a six-inch (15 cm) pressure relief flanged top-mounted nozzle. The craftsman also capped two smaller nozzles on the tank roof with flanges. These smaller nozzles normally were equipped with a pressure gauge and

FIGURE 3-1 An API 620 tank is damaged during a hydrotest.

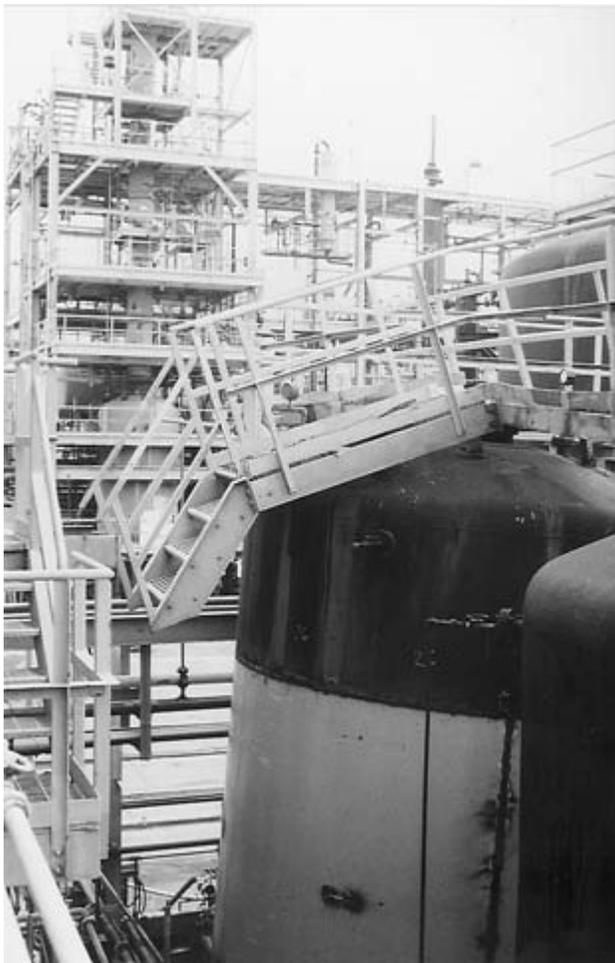
When the maintenance crew returned to the job site a short time later, they observed a water stream forcefully squirting from the two 1/2-inch vents. They noticed this normally vertical tank leaning at a slight angle. The bottom bulged upward at the bottom-to-shell joint as much 8 inches (20.3 cm) above the foundation. Anchor nuts ripped through the anchor chairs, and catwalks attached to the tank roof had torn away from welded clips.

FIGURE 3-2 A closer look at the slightly leaning tank and the walkway that was torn off during the hydrotest.

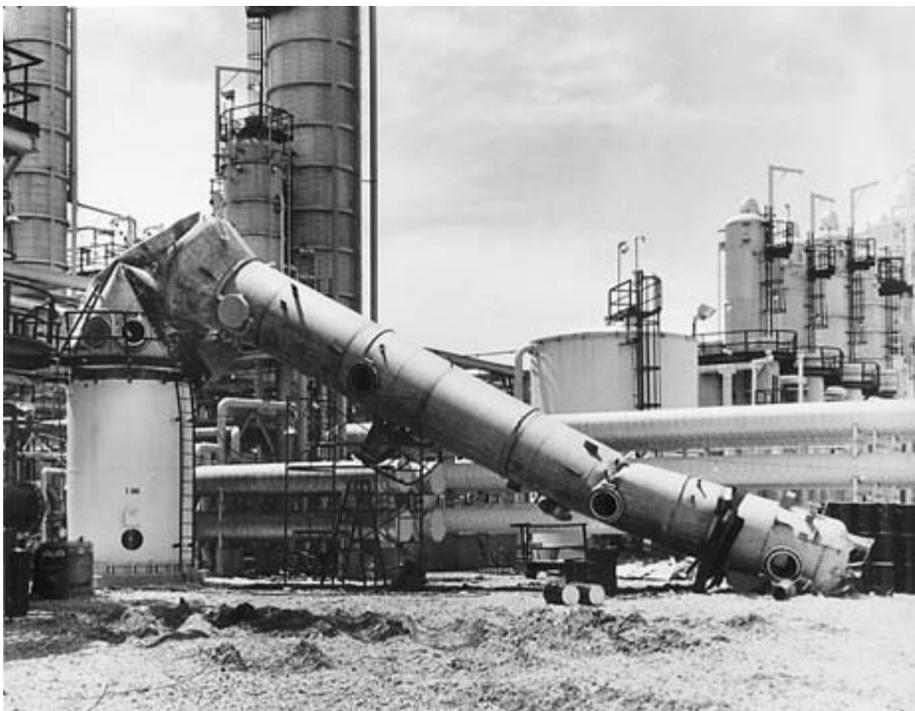
At the time of the incident, the operating team was preparing to simulate operations by circulating water in the system. Shortly after midnight, operators noticed water coming from the reabsorber vent. Pre-op engineers concluded that water had flooded both the

FIGURE 3-5 A stripper column collapses. Courtesy of Guido DeJesus.

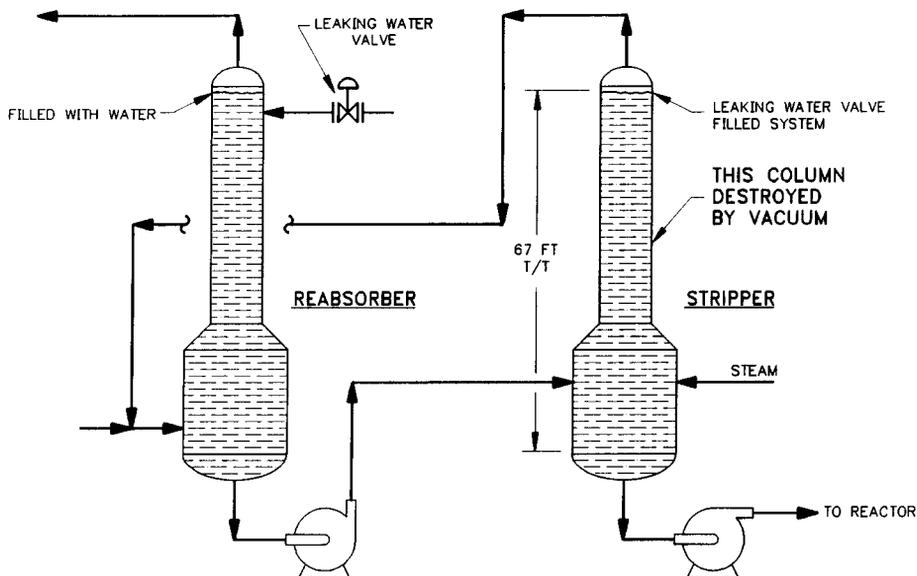
FIGURE 3-6 The design of the reabsorber/stripper system. Courtesy of Guido DeJesus and Warren Schindler.

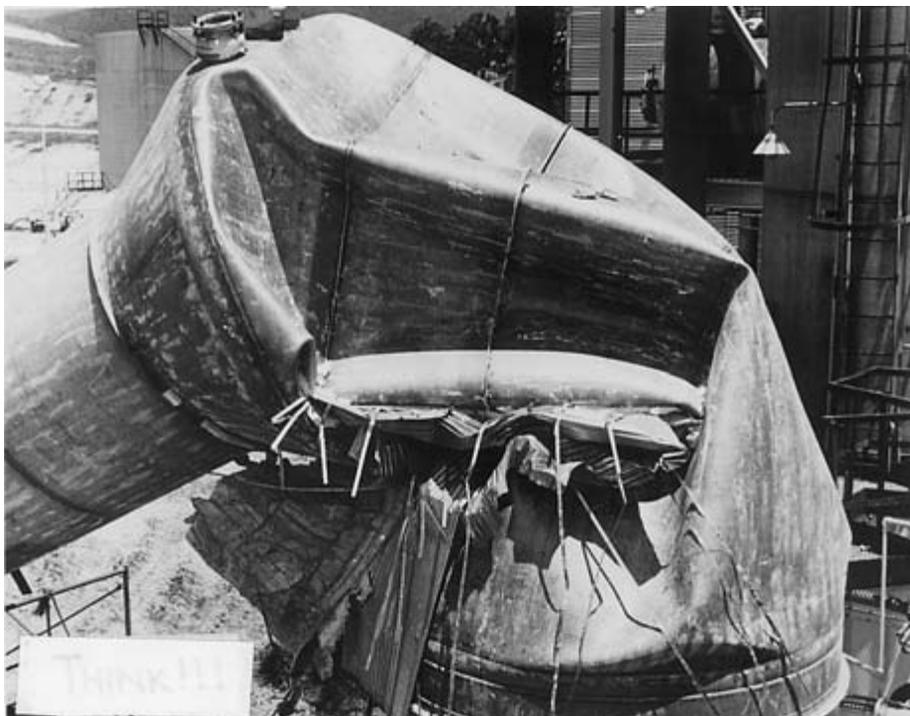
FIGURE 3-7 A close-up of a collapsed stripper column.
Courtesy of Guido DeJesus.

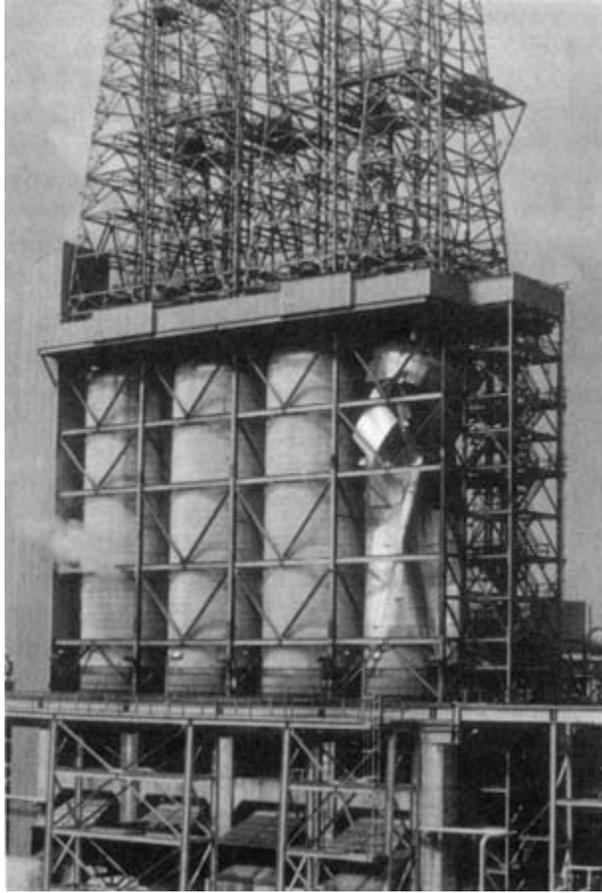
FIGURE 3–9 Collapsed coker drum in a refinery. Courtesy of S. O. Kapenieks.

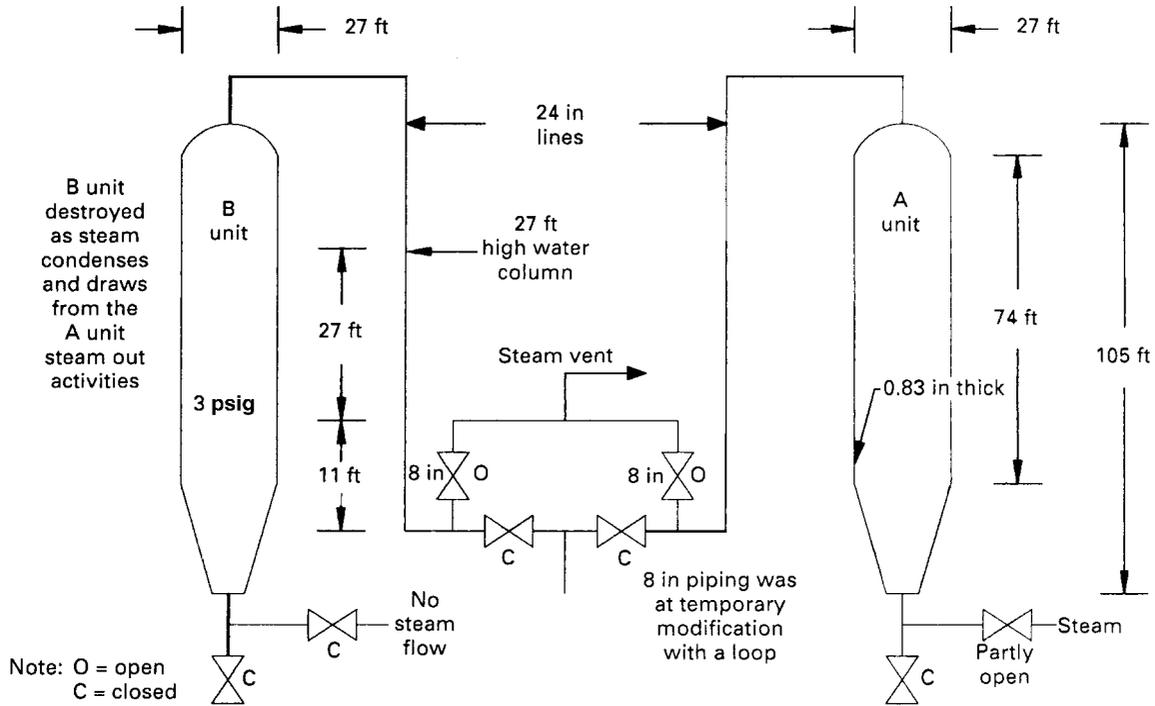
These gigantic pressure vessels were over 100 ft. (30 m) high, 27 ft. (8.2 m) in diameter, and the main body was a straight side cylinder 74 ft. (23 m) long. The cokers were designed for 55 psig (380 kPa) internal pressure. The coker drum has a dome-shaped top

FIGURE 3-10 Conditions at the time of the failure of the coker drum.

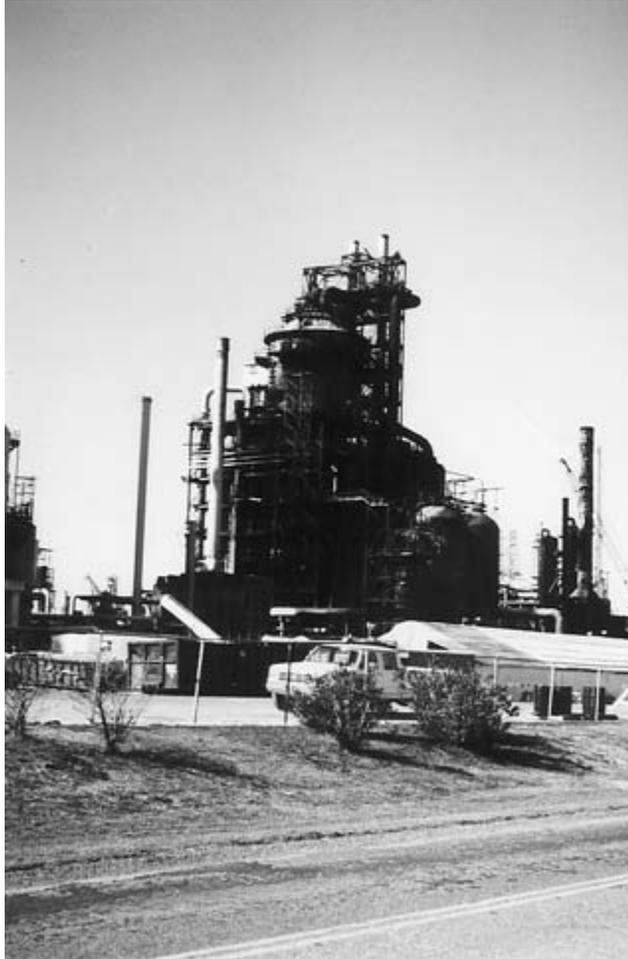
FIGURE 3–12 After the explosion, a charred multi-storied catalytic cracking unit.

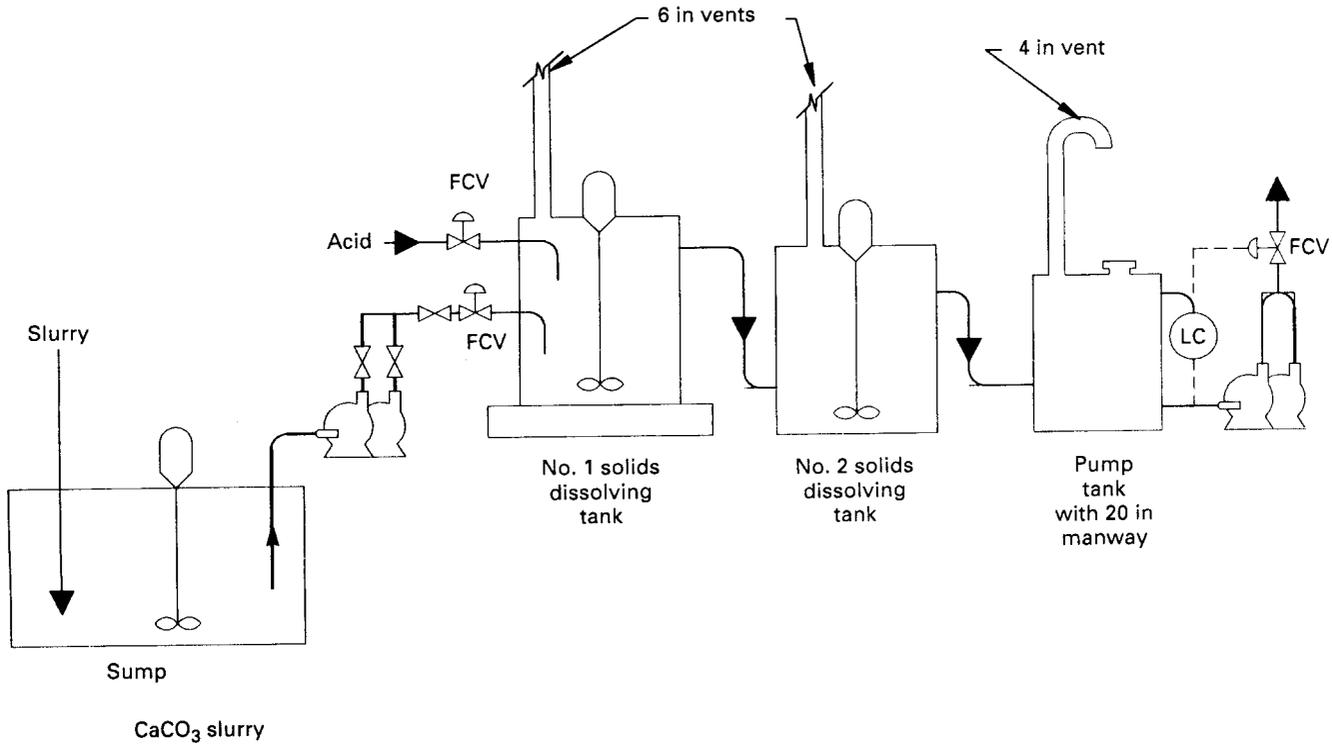
FIGURE 4-3 Slurry-dissolving system. Courtesy of J. M. Jarnagin.

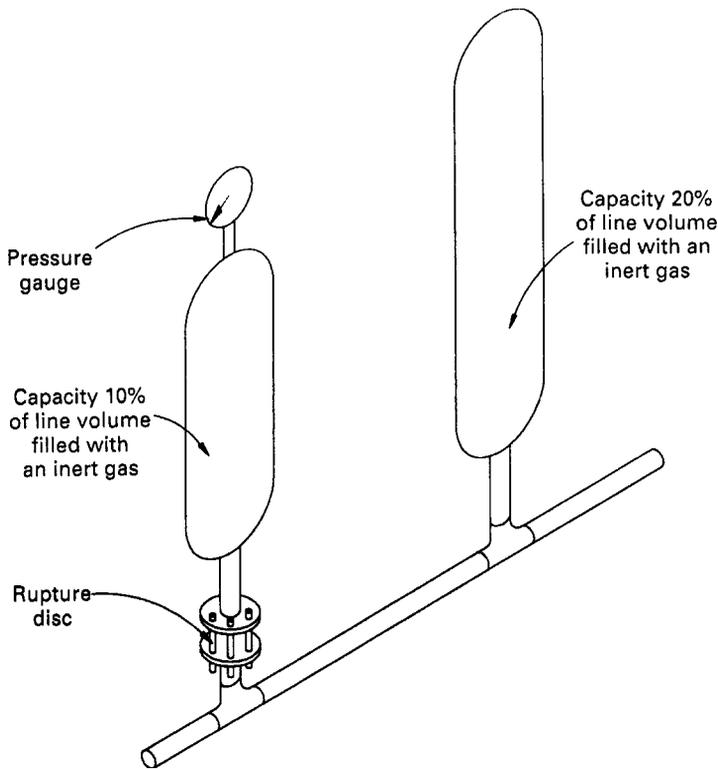
FIGURE 4-4 Expansion chambers for liquid chlorine pipeline protection. Courtesy of the Chlorine Institute, Inc.

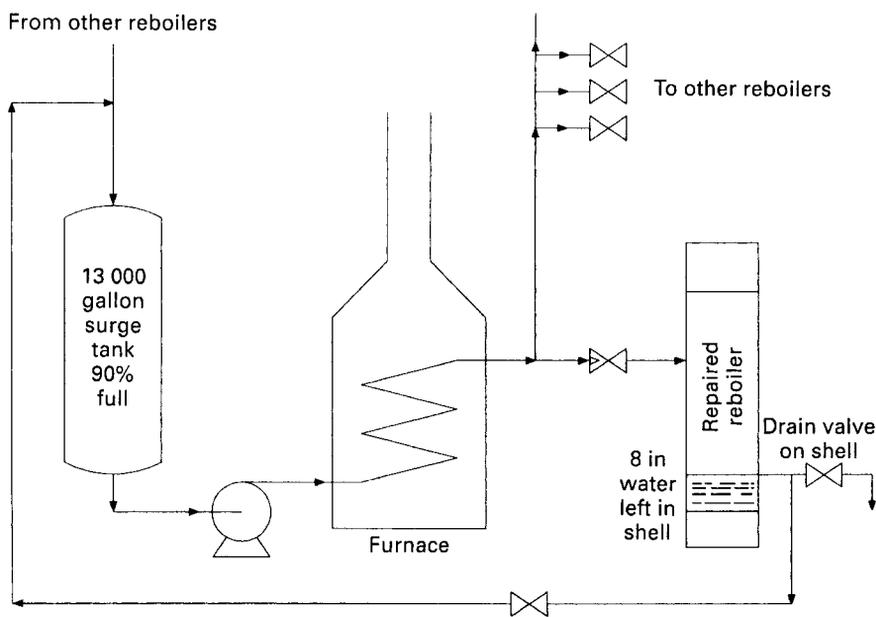
FIGURE 5–1 Residual, undetected water from a hydrotest explosively vaporizes and ruptures a surge tank. Courtesy of Trevor A. Kletz.

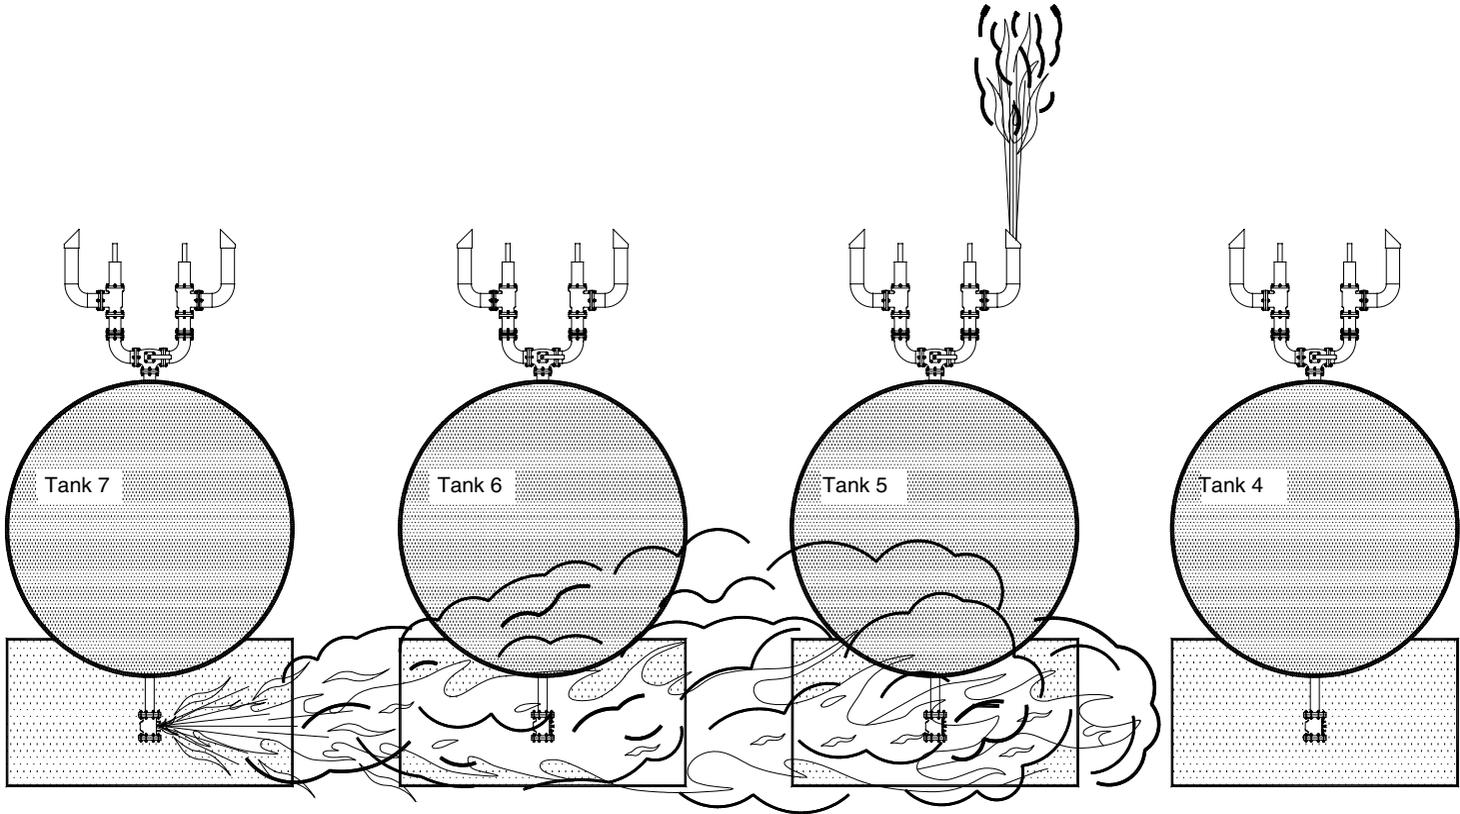
FIGURE 5-9 Flames Below the Vinyl Chloride Tanks—An Artist's Perception. Courtesy of Manuel David.

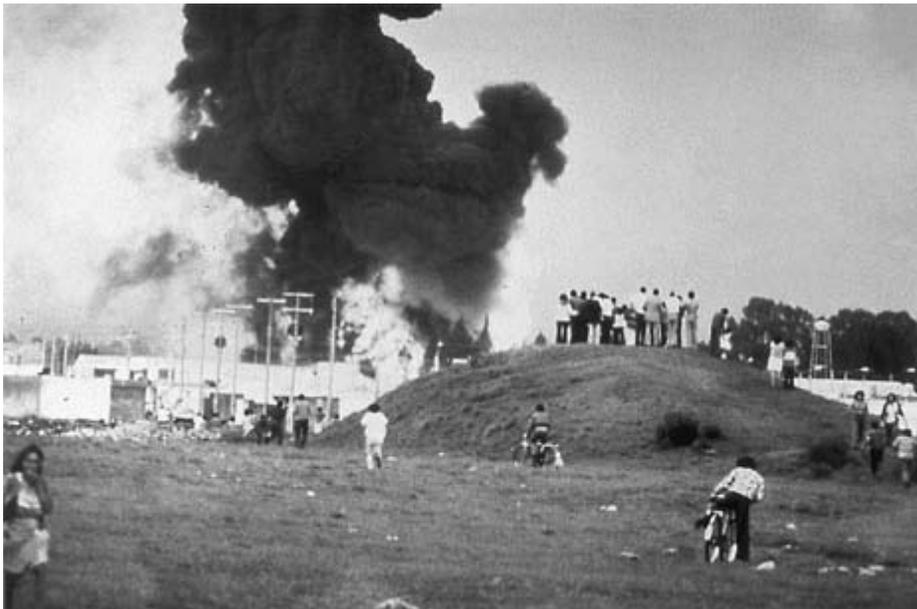
FIGURE 5-10 BLEVE of a vinyl chloride storage tank. Courtesy of the Institution of Chemical Engineers.

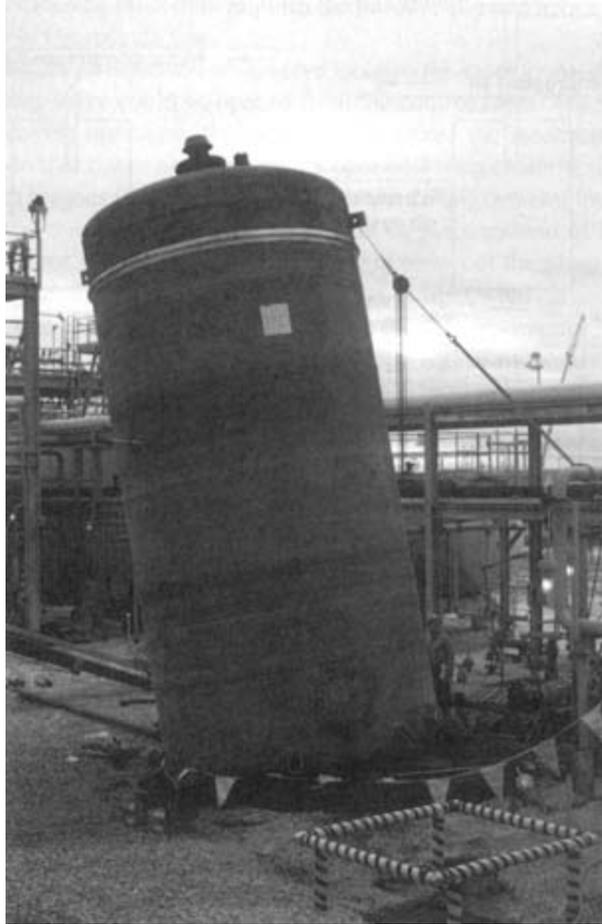
FIGURE 5-12 A large acid tank fails due to blocked vent and a blocked overflow line.

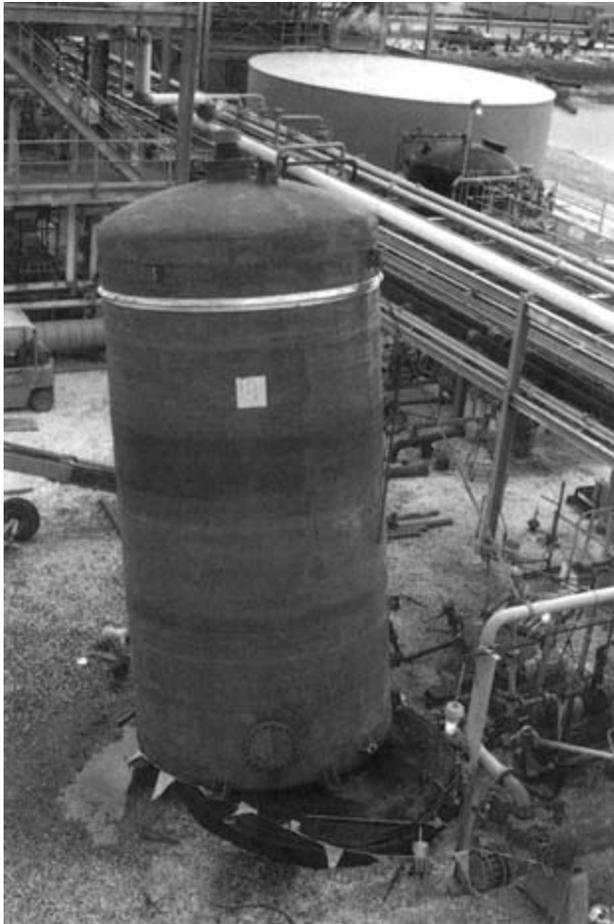
FIGURE 5-13 An aerial view of the tank failure.

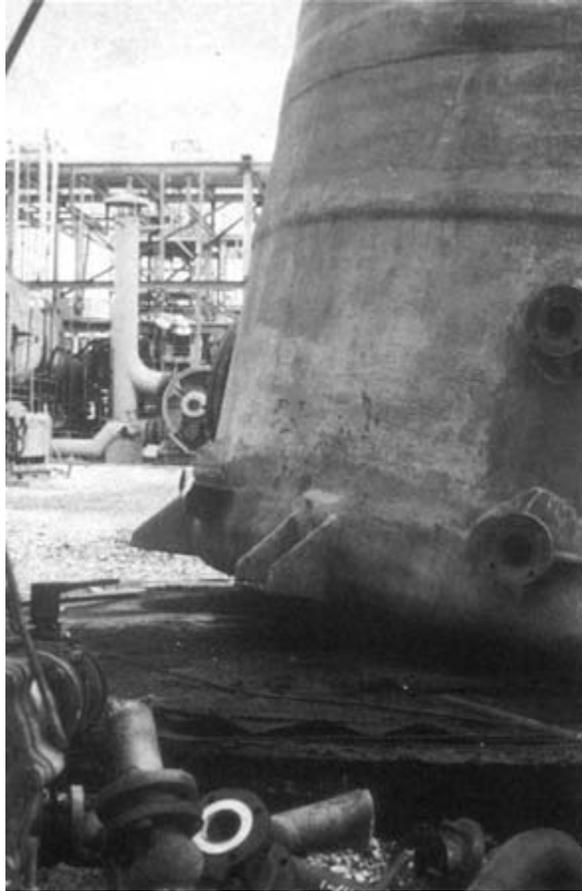
FIGURE 5-14 A close-up of the failed tank base.

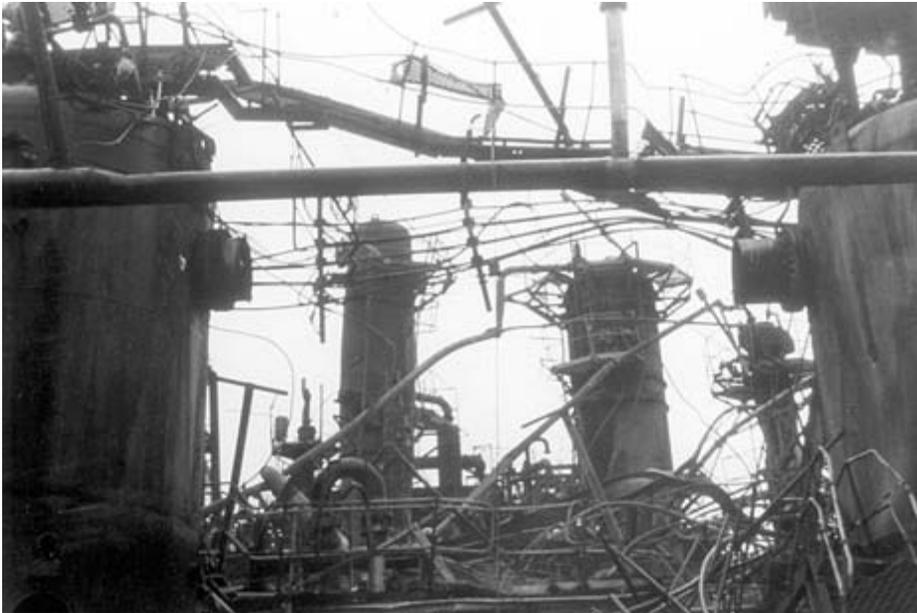
FIGURE 5-16 A Destroyed Section of the Flixborough Reactor System.
Photo courtesy of Trevor A. Kletz.

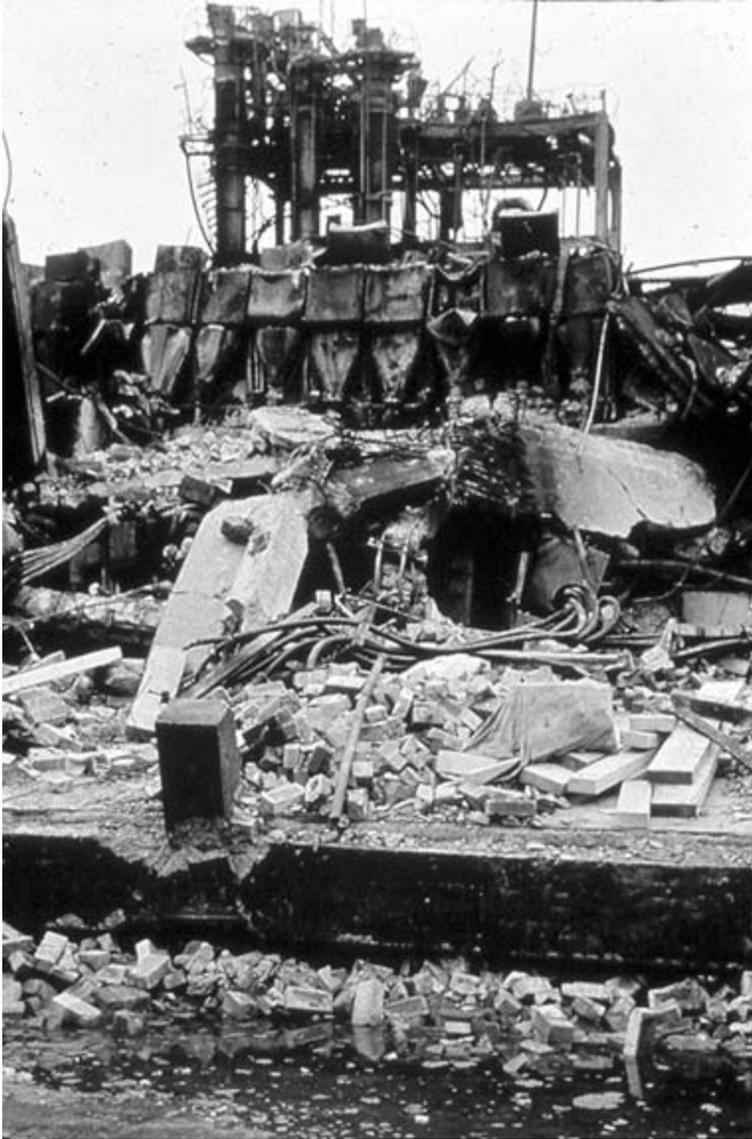
FIGURE 5-17 The rubble of the crushed control room at Flixborough. Courtesy of Trevor A. Kletz.

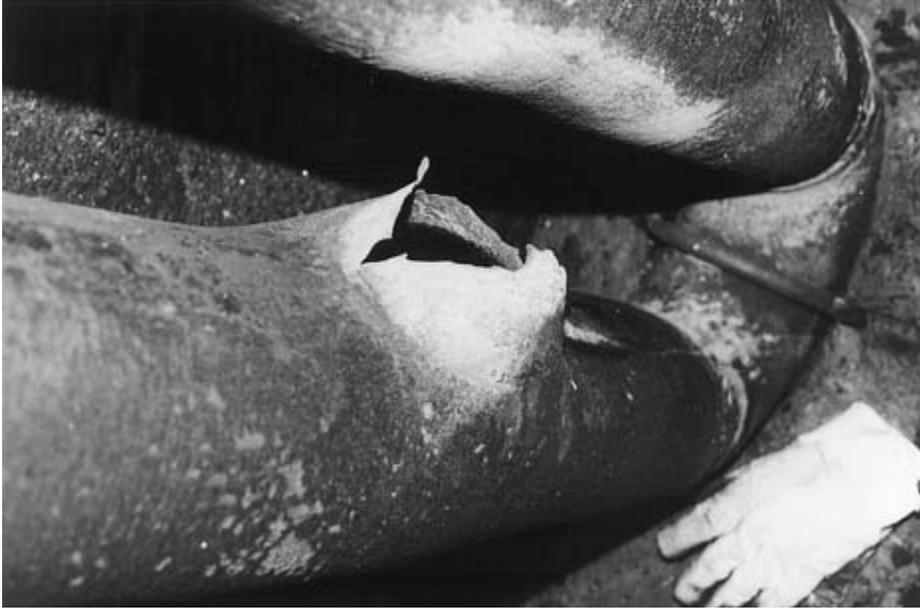
FIGURE 6-2 Tube rupture in a fired heater.

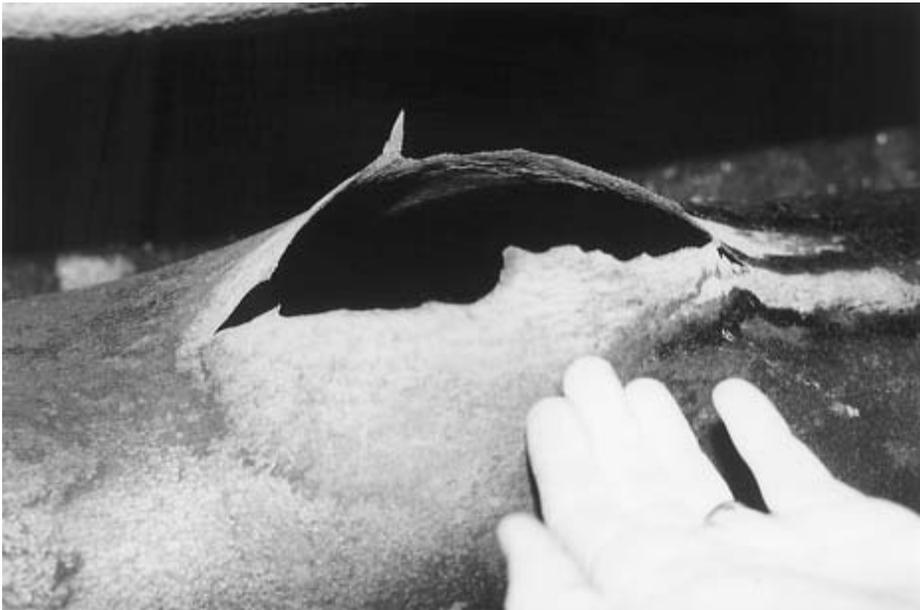
FIGURE 6-3 Close-up of the tube failure.

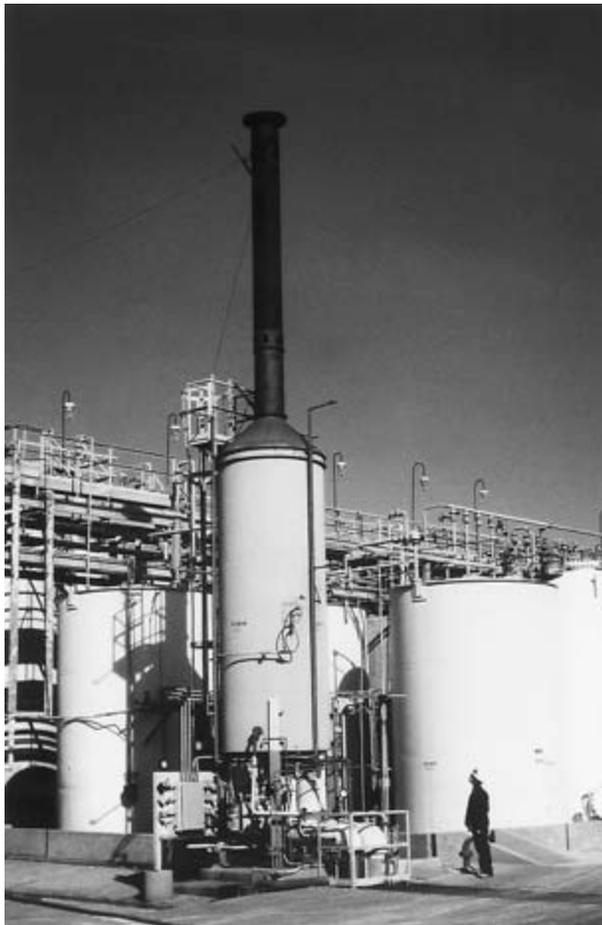
FIGURE 6-4 The rejuvenated and relocated gas-fired heater.

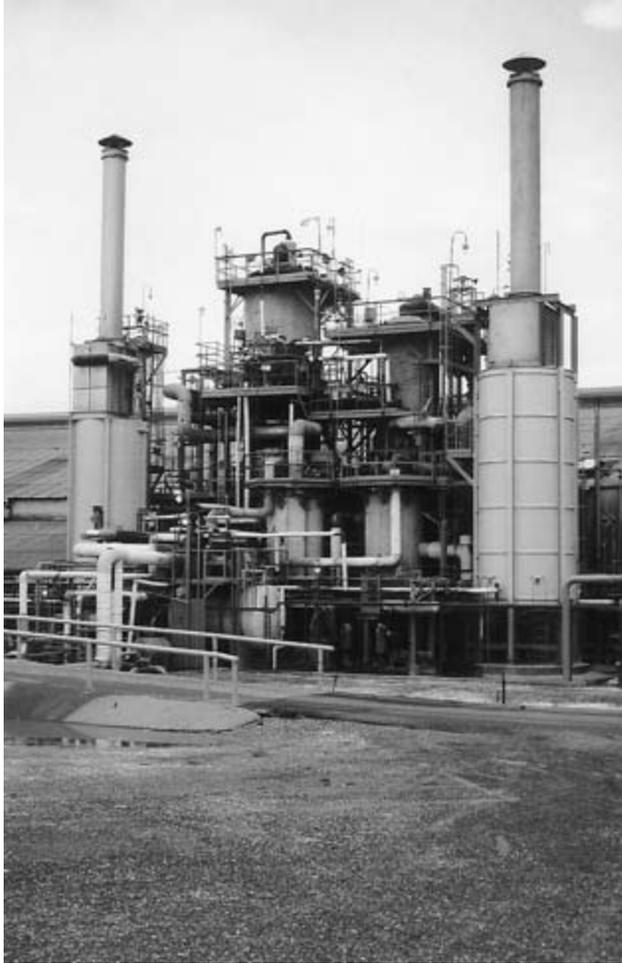
FIGURE 6-5 Well-maintained unit is troubled by a leak.

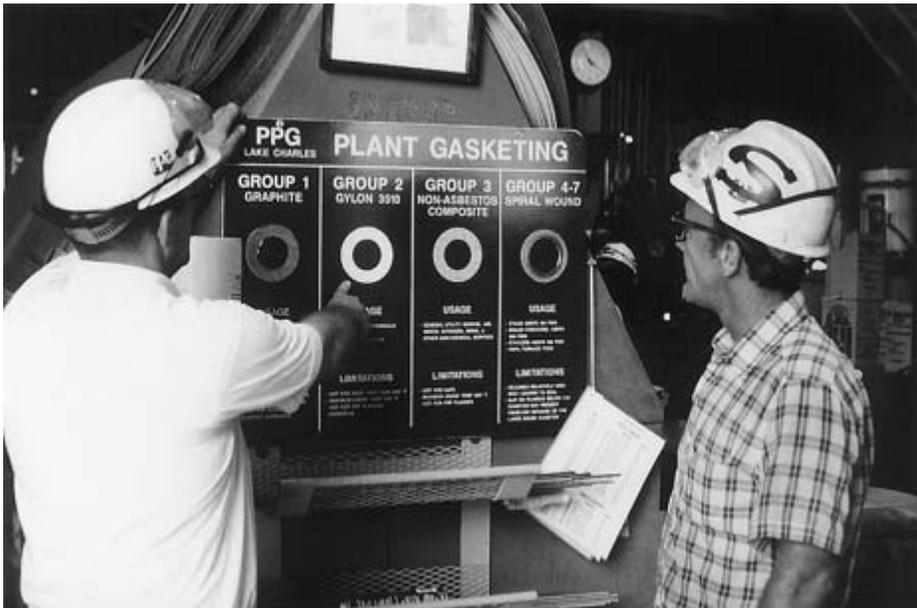
FIGURE 6-9 Choosing the proper piping gaskets with help from easy-to-understand gasket board.

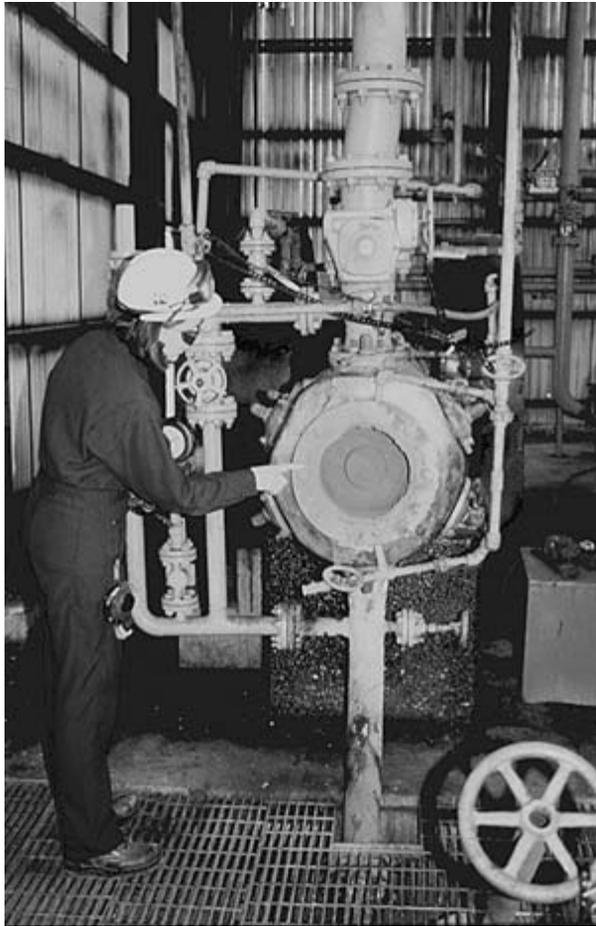
FIGURE 7-1 Reciprocating compressor with ruptured water jacket.
