Chemical Process Safety

Learning from
Case Histories

Third Edition

ROY E. SANDERS

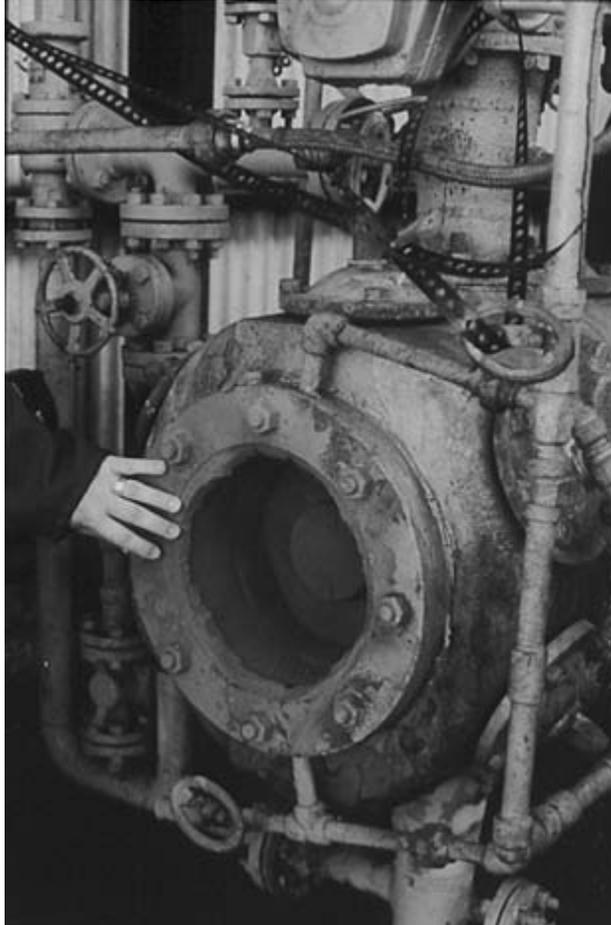
FIGURE 7-2 Close-up of ruptured water jacket on compressor.

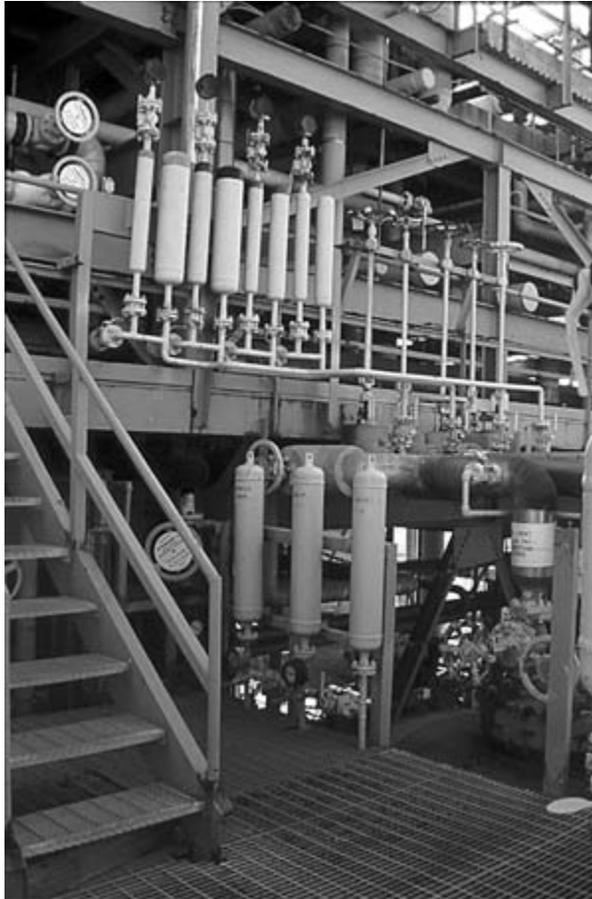
FIGURE 7-5 Expansion bottles protecting piping from overpressure.

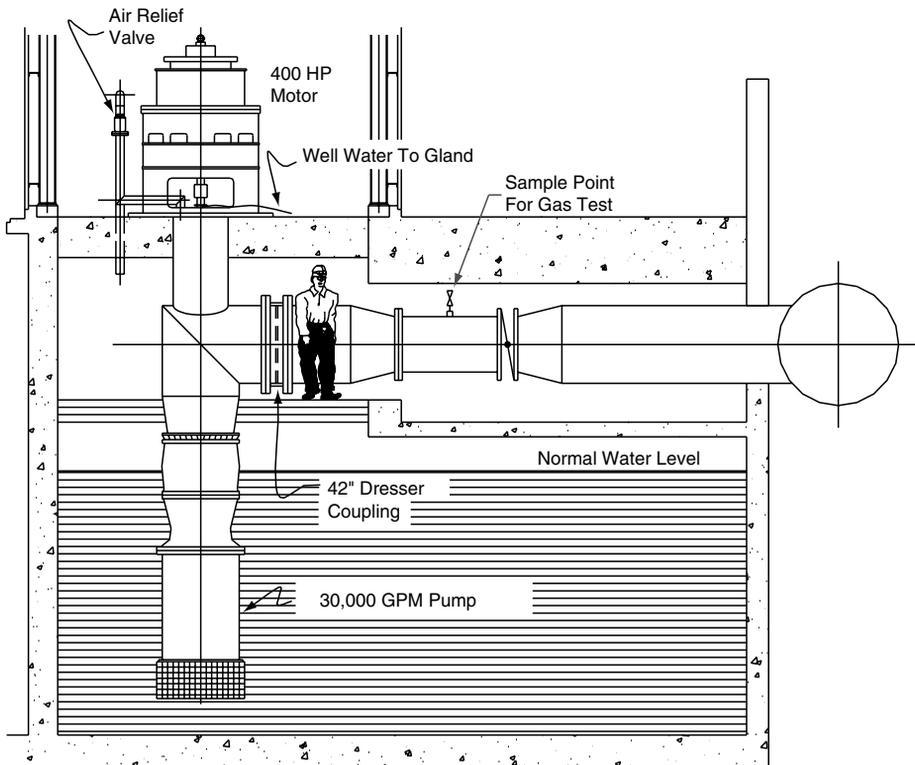
FIGURE 7-8 Sketch of the river water pump system at normal conditions. Courtesy of Manuel David.

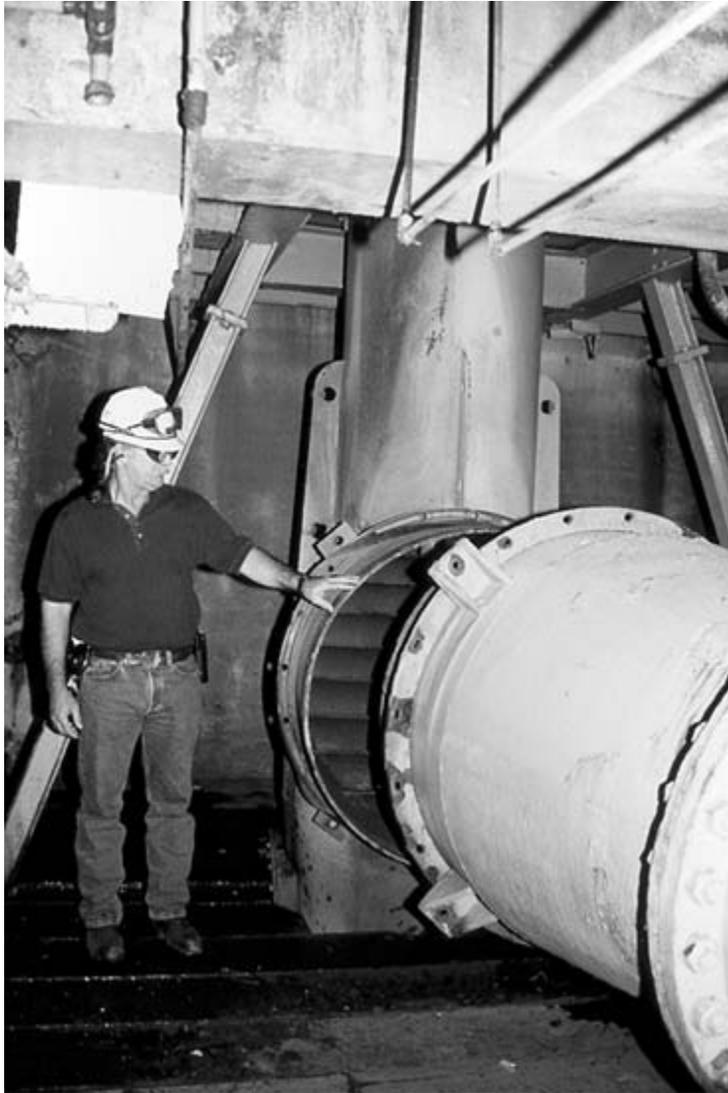
FIGURE 7-9 Photo of how the river water pump moved during the explosion.

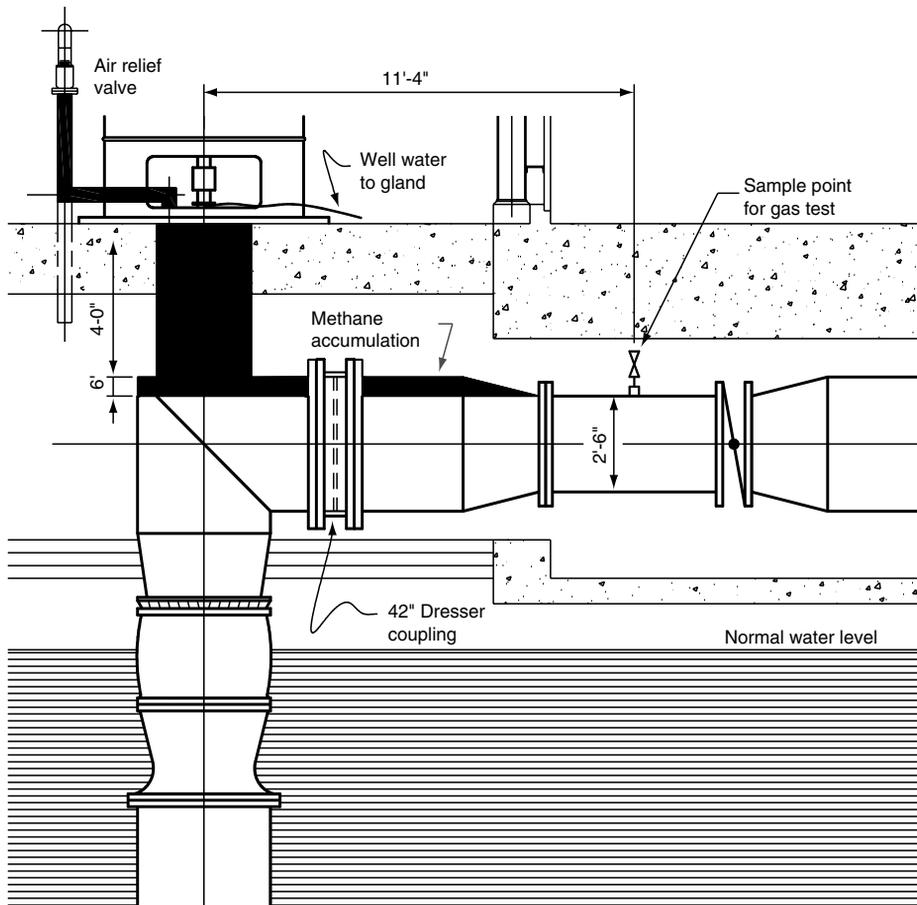
FIGURE 7-11 Sketch of how methane gas accumulated in the river water piping.

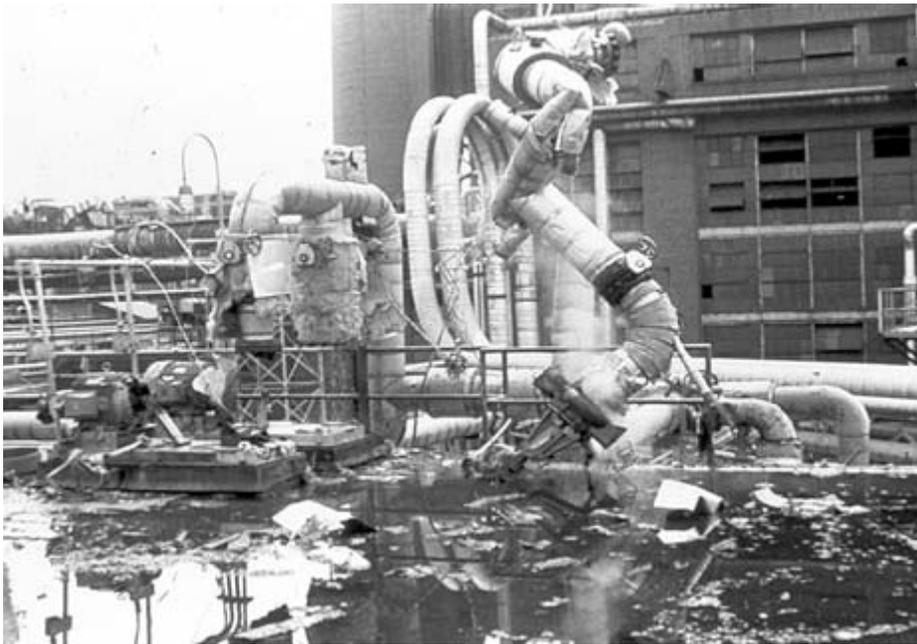
FIGURE 7-15 Heavily damaged condensate pump installation. Courtesy of Eastman Chemical Company.

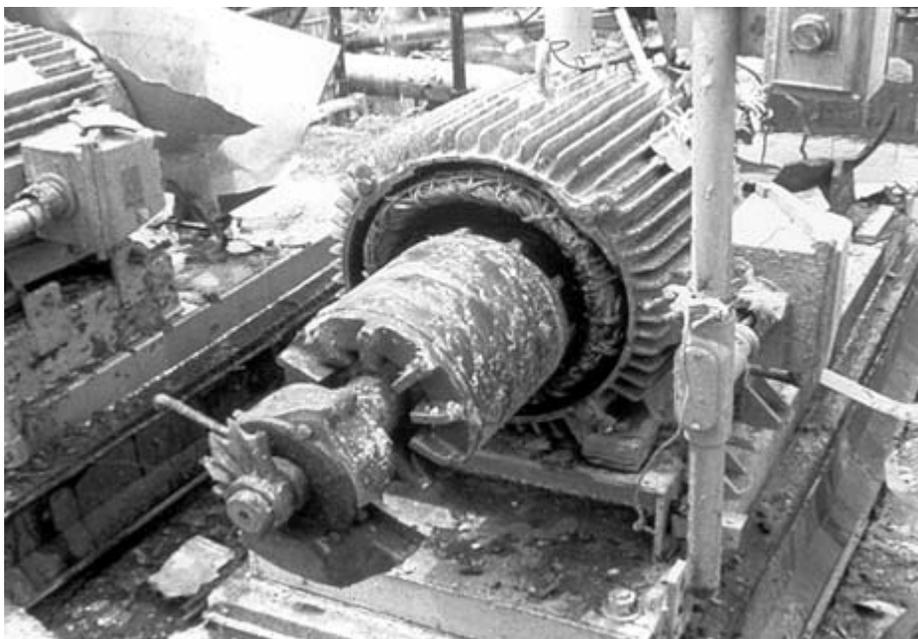
FIGURE 7-16 Explosion forces rotor out of condensate pump motor. Courtesy of Eastman Chemical Company.

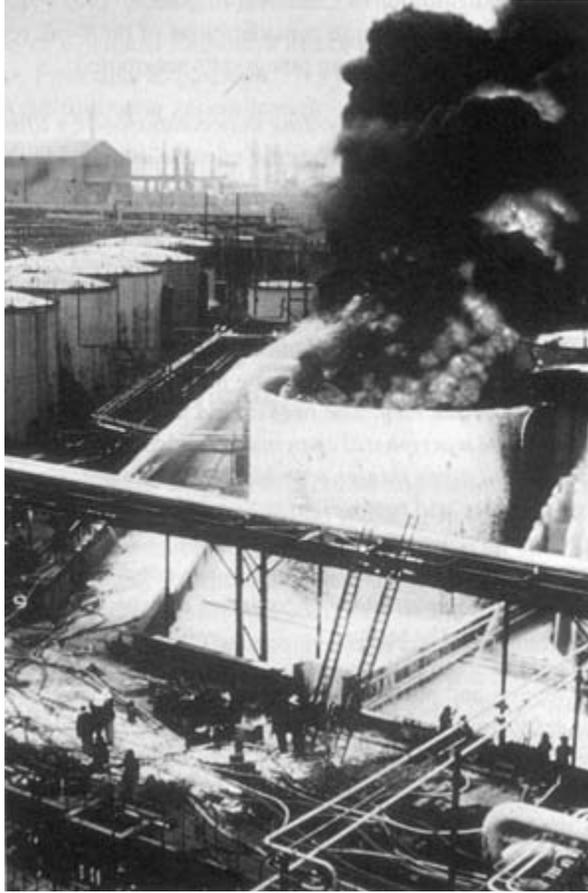
FIGURE 8-3 A fire in a giant floating roof crude oil tank. Courtesy of the Institution of Chemical Engineers. This photo can be found in Hazard Workshop Module No. 6, “Preventing Emergencies in the Process Industries, Volume 1.”

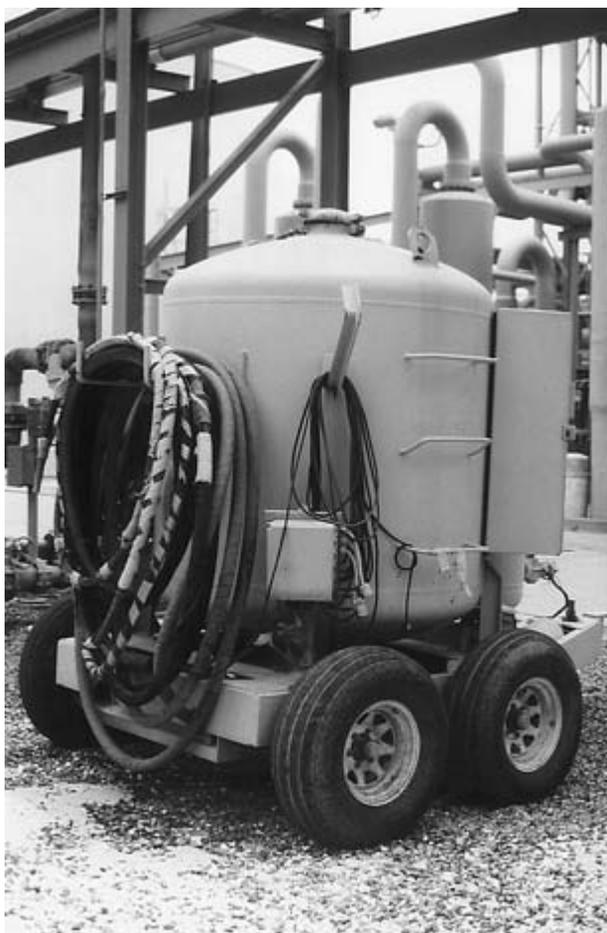
FIGURE 8-4 Repairs to a portable sandblast pot do not meet specifications and the lid flies off.

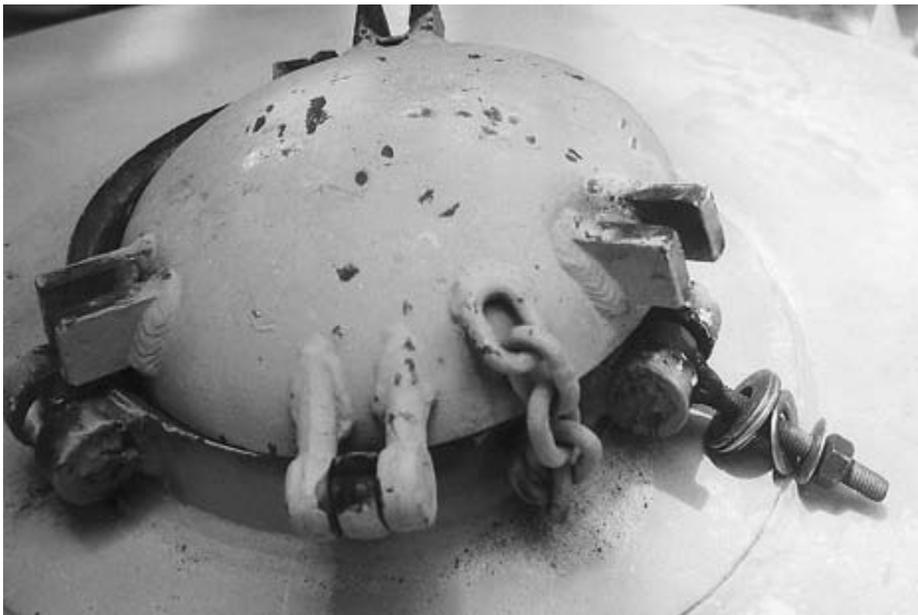
FIGURE 8-5 A close-up look at the quick closure bolts that failed on the sand pot.

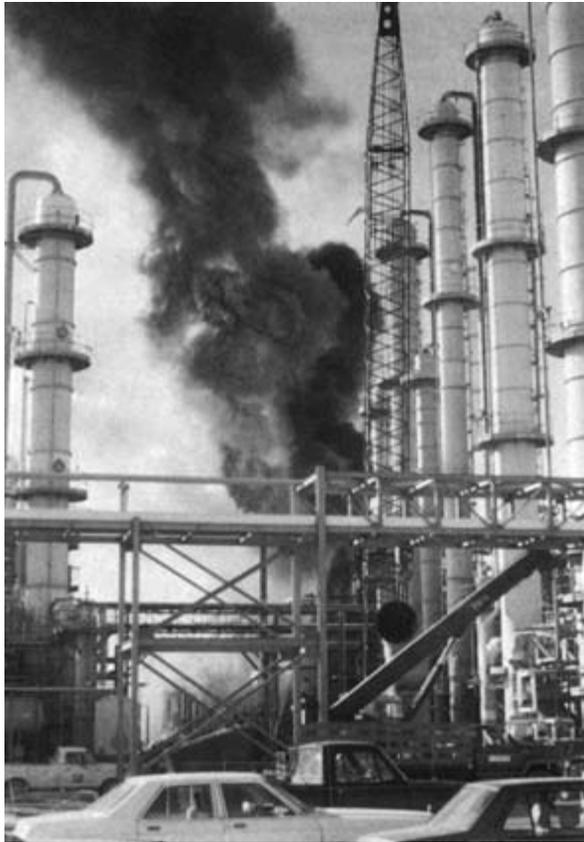
FIGURE 8-6 Fire in solvents plant as seen from the road. Courtesy of G. O. Heintzen.

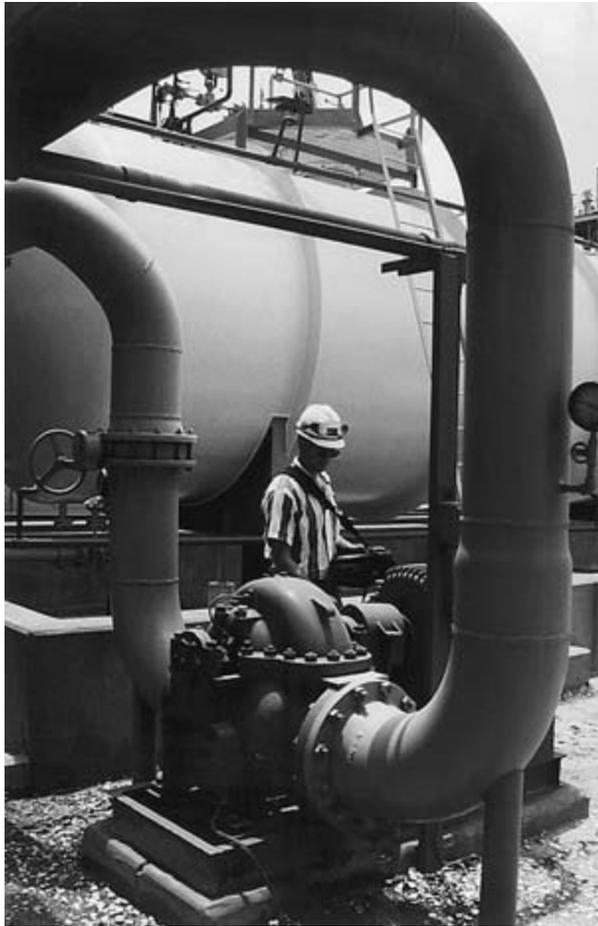
FIGURE 10-2 A vibration technician taking readings on a cooling water pump.

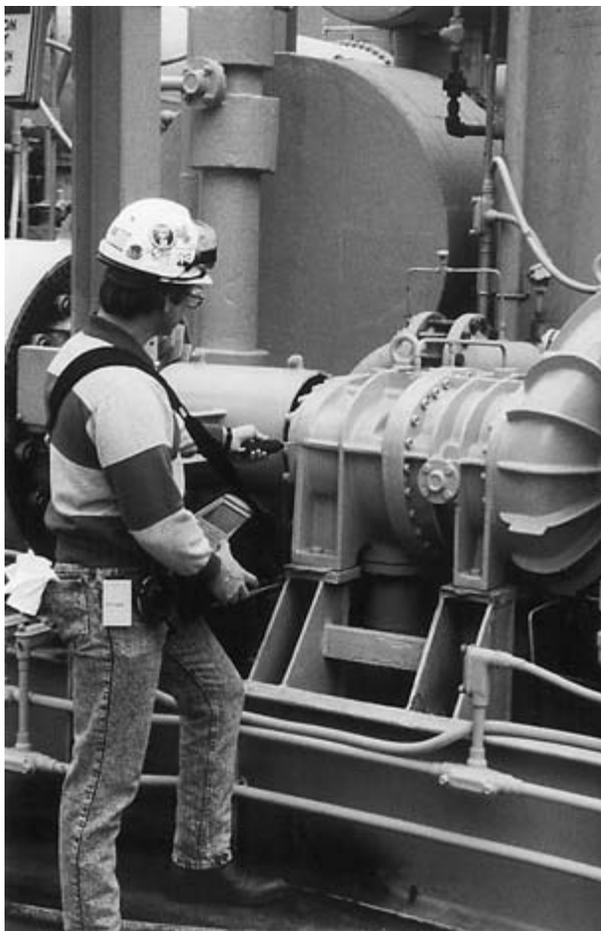
FIGURE 10-3 A vibration technician taking readings on a refrigeration compressor.

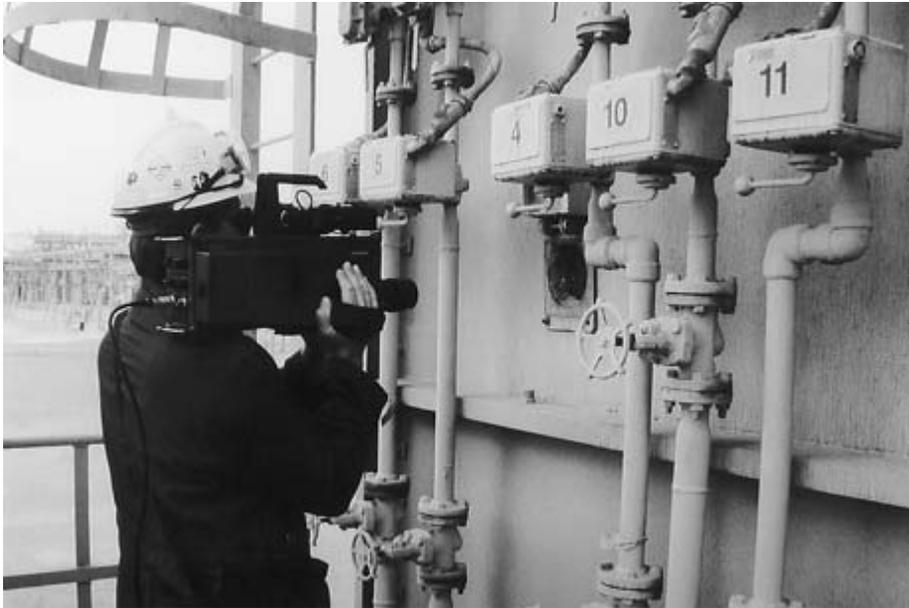
FIGURE 10-5 An inspector using an infrared camera periodically monitors furnace tube temperatures through the inspection port holes.

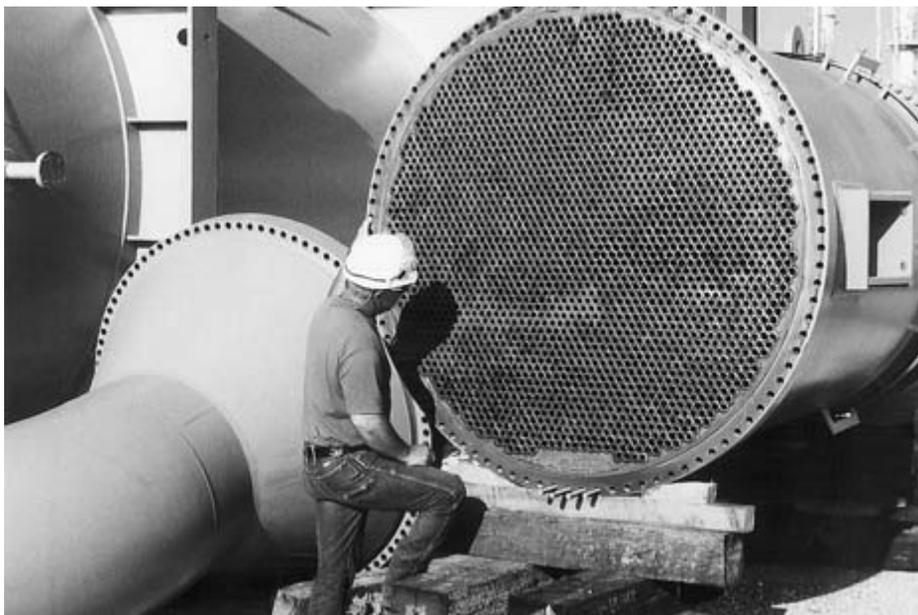
FIGURE 10–6 An inspector inspects new and repaired heat exchangers at the fabrication/repair shop and when they arrive at the plant site.

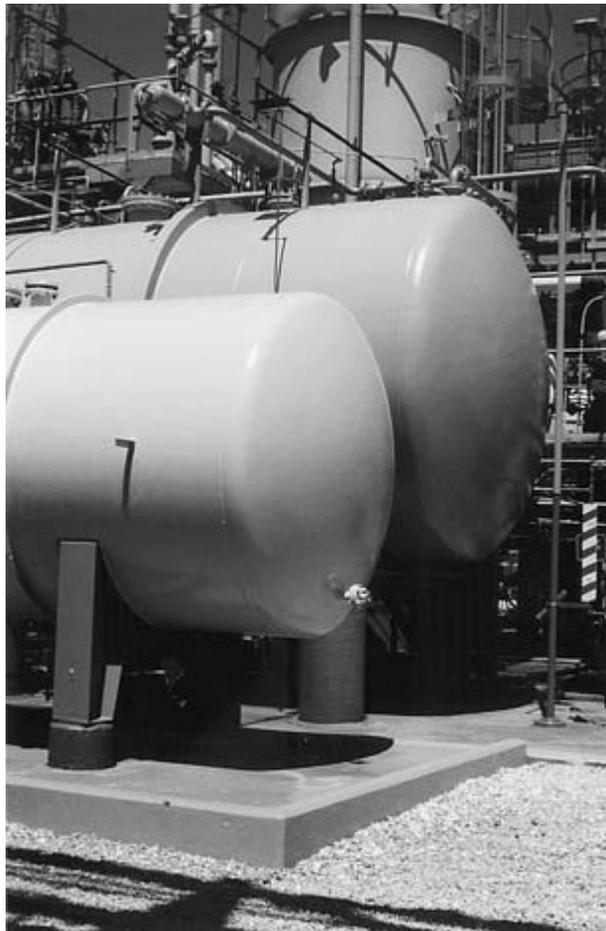
FIGURE 10–7 Well-maintained pressure vessels (over 30 years old) still safely handling hazardous materials.

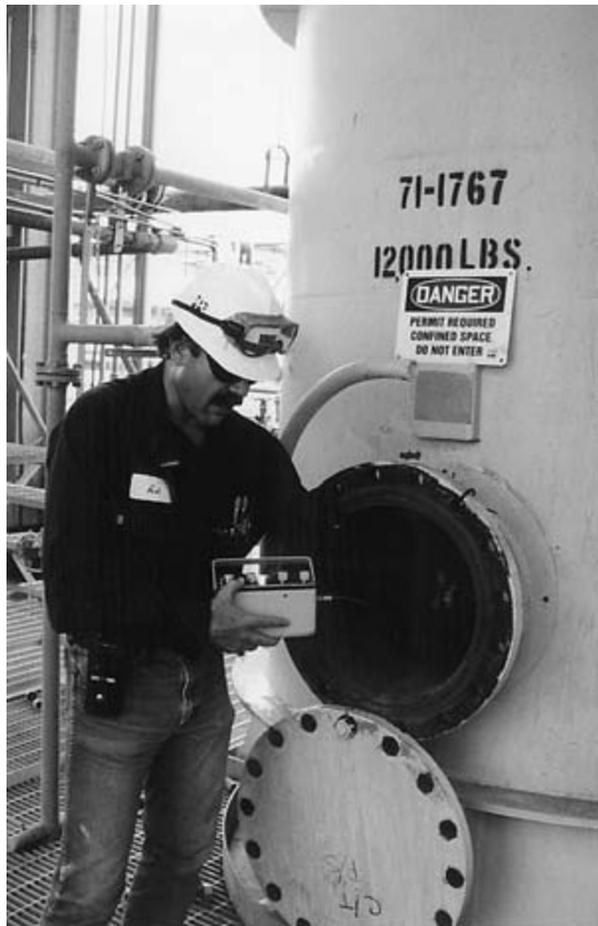
FIGURE 10–8 An operations foreman checks for blinding and samples the vessel's atmosphere before tank entry.

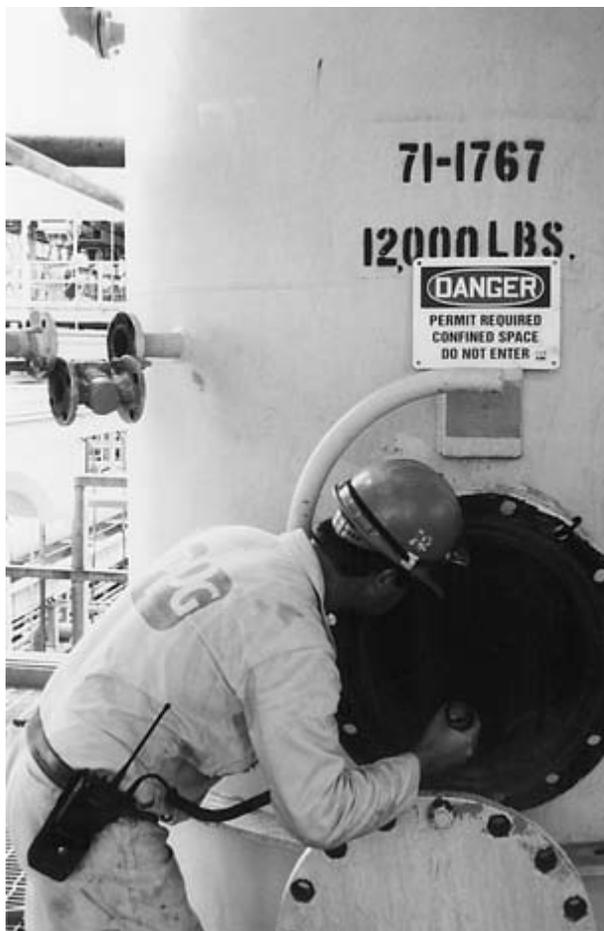
FIGURE 10-9 A pressure vessel inspector making an initial assessment of the vessel and determines any special inspection needs, such as ladders, scaffolding, or extra lighting.

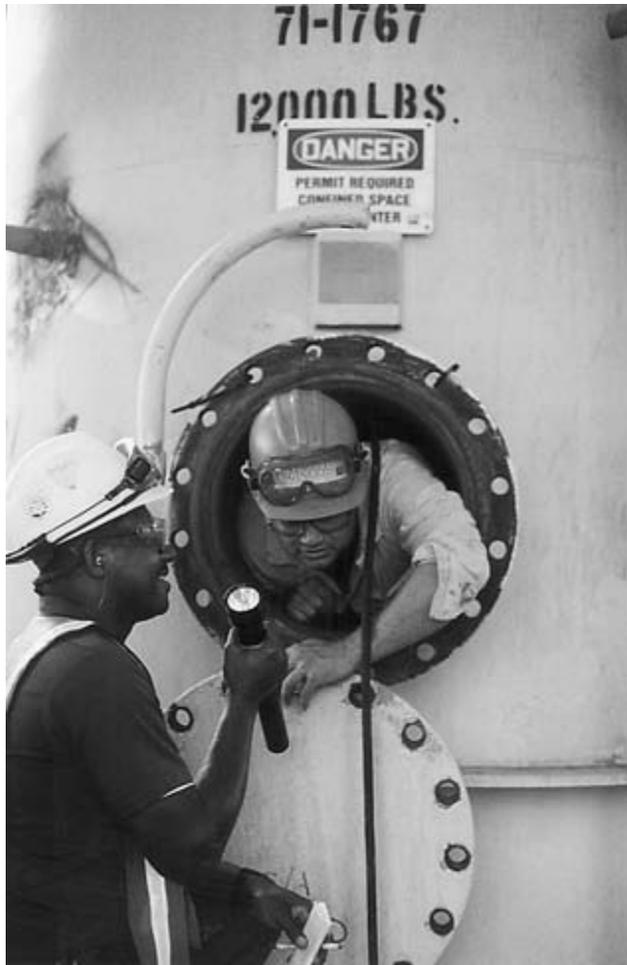
FIGURE 10–10 A pressure vessel inspector enters the confined space after the vessel is blinded, tested, and cleared, but still relies on a manway watch.

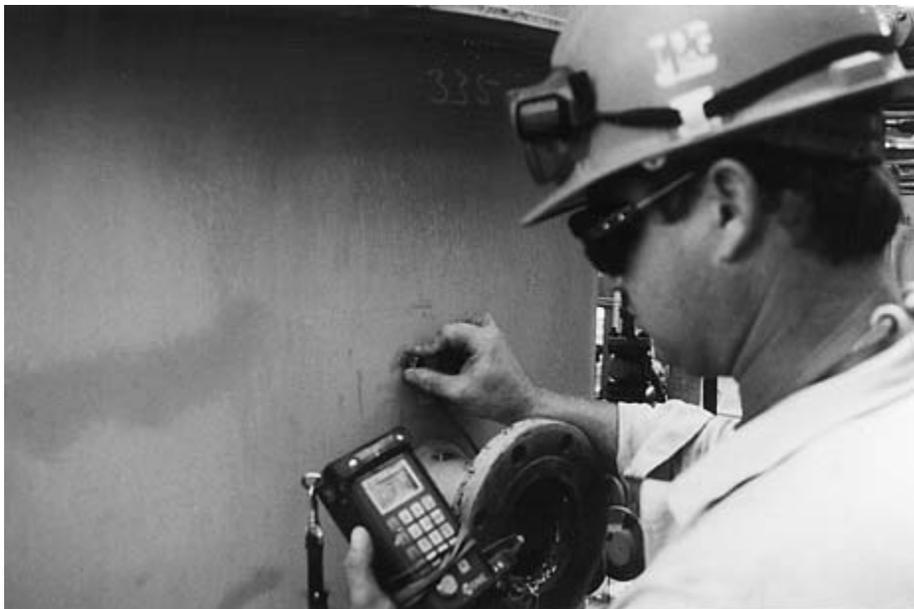
FIGURE 10–11 An inspector verifying wall thickness on a vessel near a nozzle that had experienced metal loss.

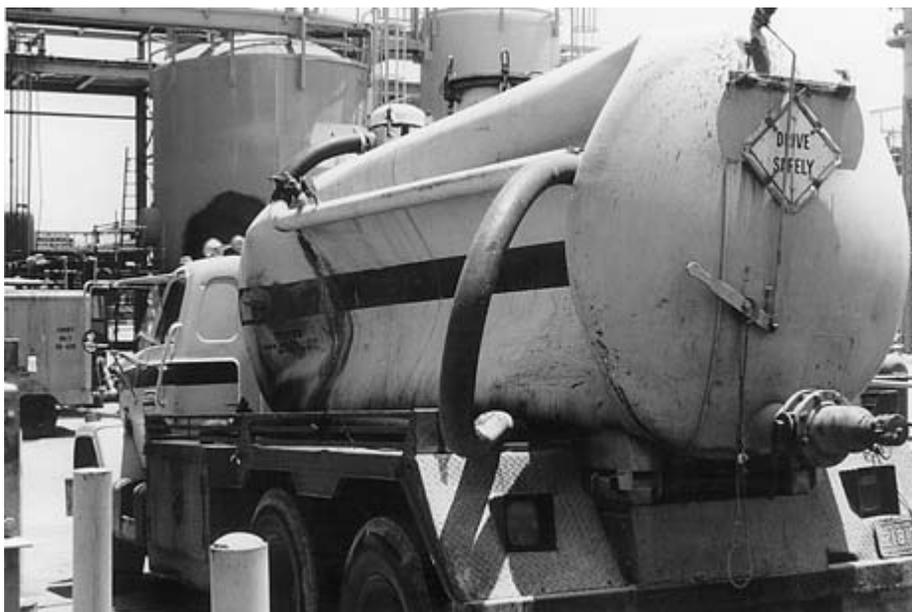
FIGURE 10–12 A collapsed service company vacuum truck signals an inadequate mechanical integrity program.

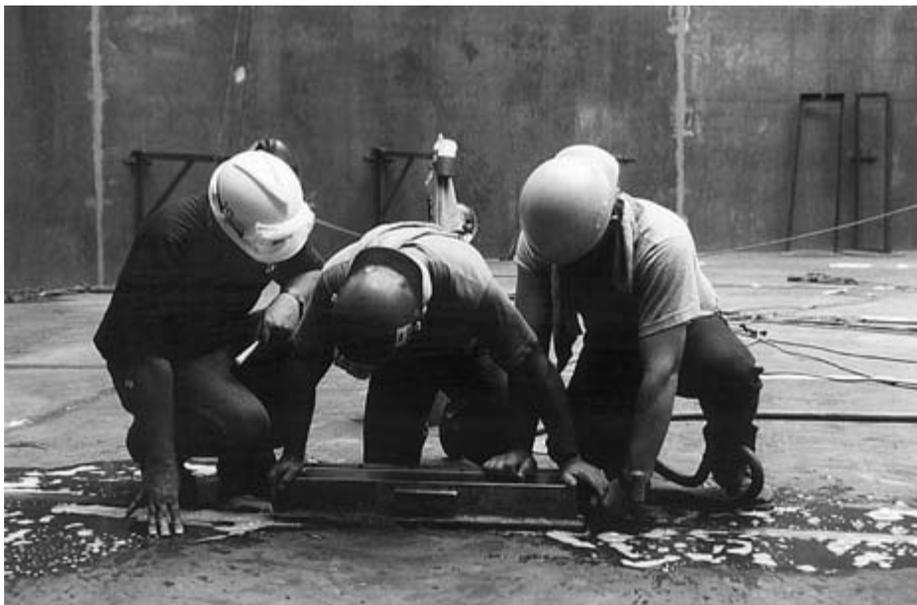
FIGURE 10–13 Inspectors using a vacuum box and soapy water to check for leaks in welds on the floor of low-pressure tanks.

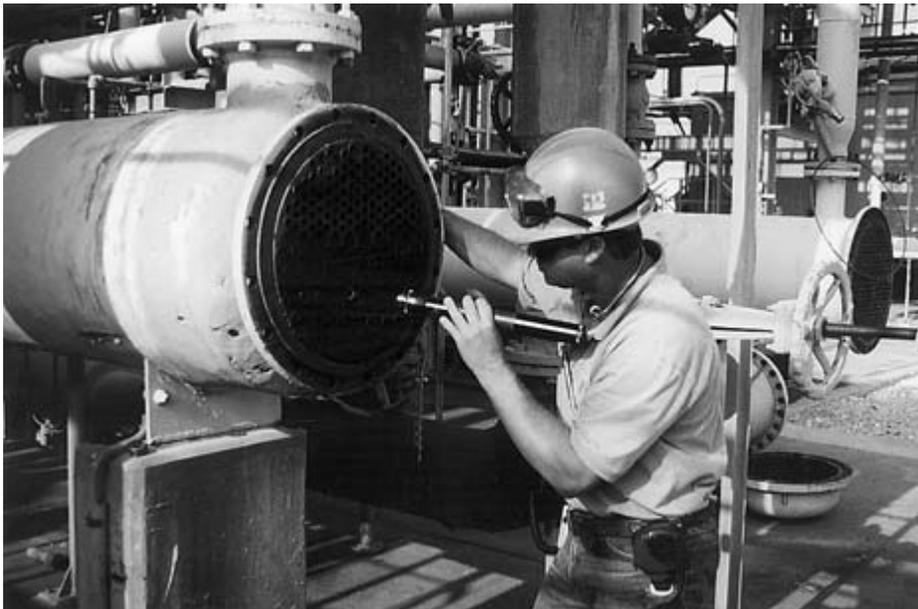
FIGURE 10-14 An inspector examines the condition of the tubes on a condenser. Water-side corrosion can occur if water treatment is insufficient.

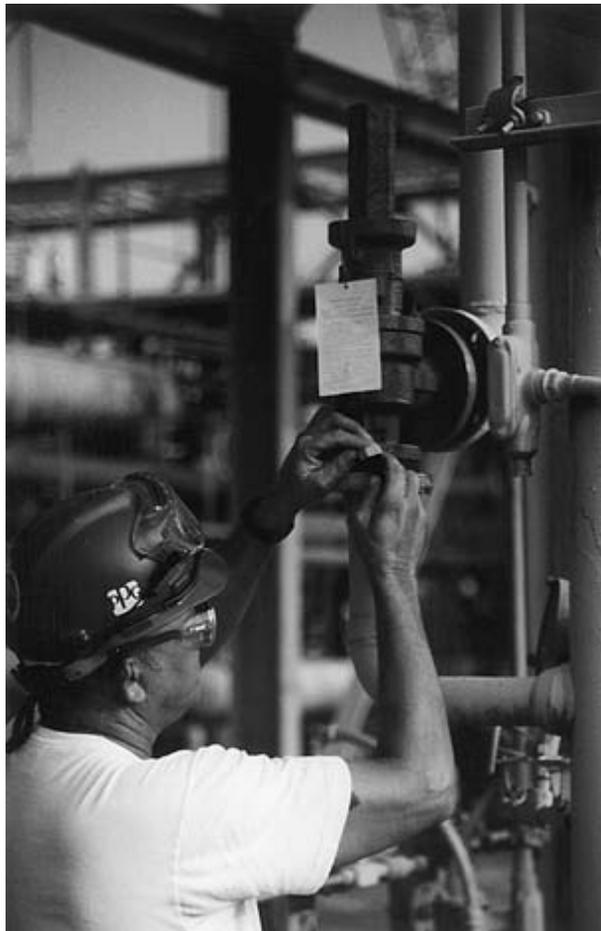
FIGURE 10–17 A mechanic is removing an SRV from a unit. The mechanic records the condition of the inlet and outlet piping components on the tag before the valve is sent for testing.

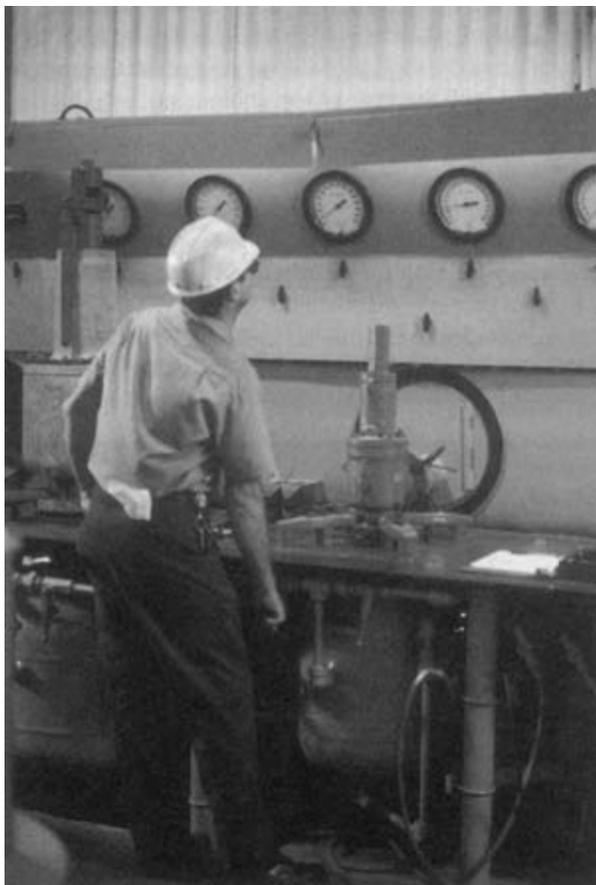
FIGURE 10-18 A well-trained mechanic testing a safety relief valve just as it is received from the unit.

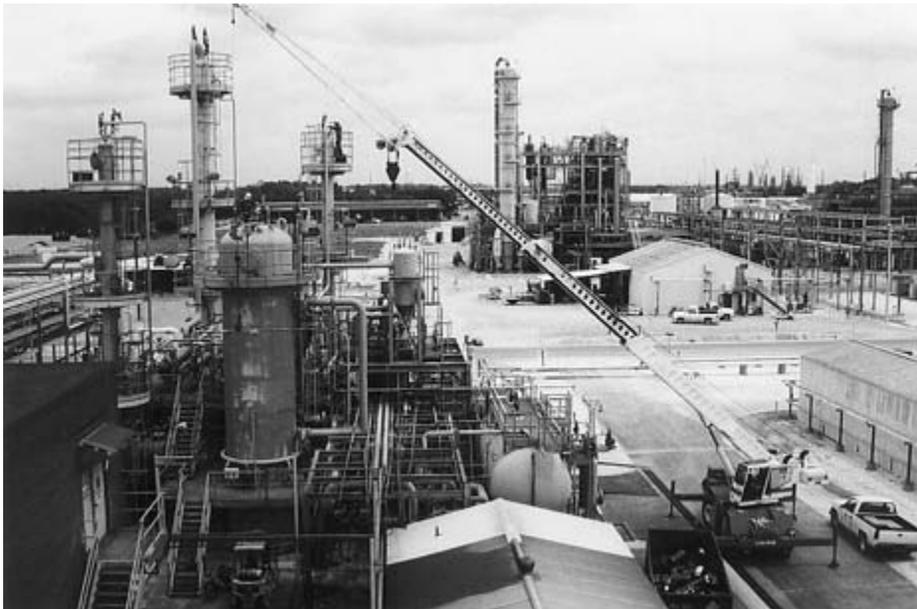
FIGURE 10-19 A crane is lifting a recently tested and reconditioned safety relief valve to reinstall on a reactor.

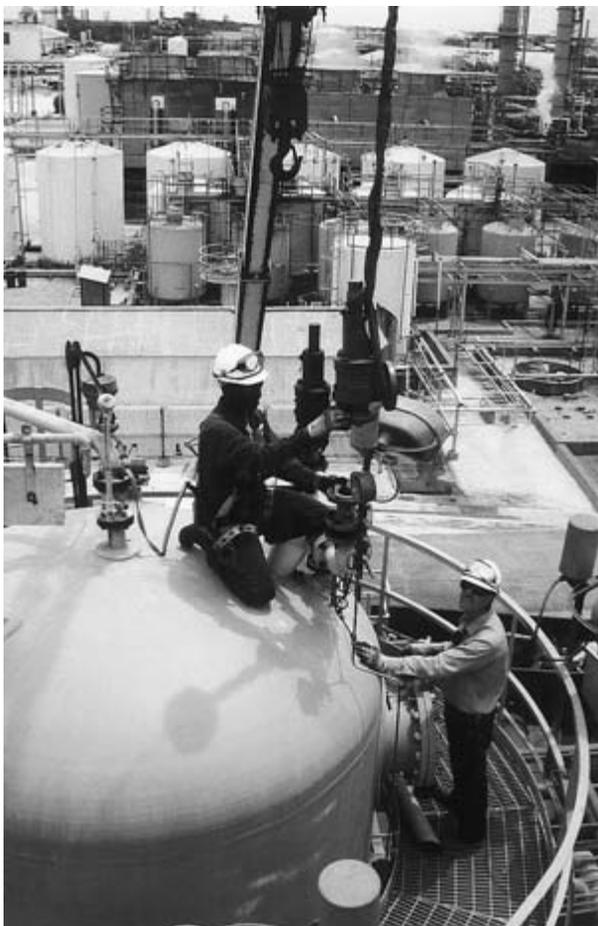
FIGURE 10–20 A mechanic is reinstalling an SRV after it was tested in the shop and raised into position by a crane.

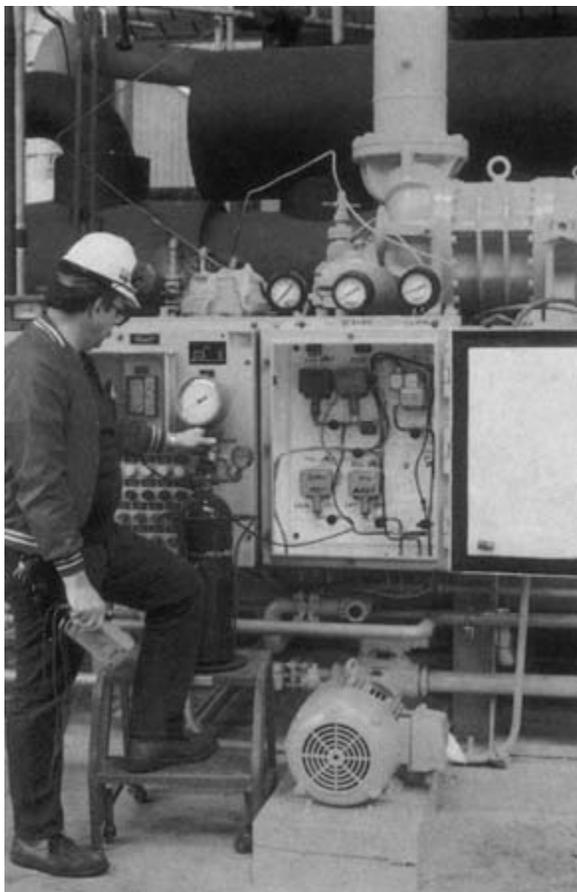
FIGURE 10–22 Prooftesting a high-pressure switch on a refrigeration unit.

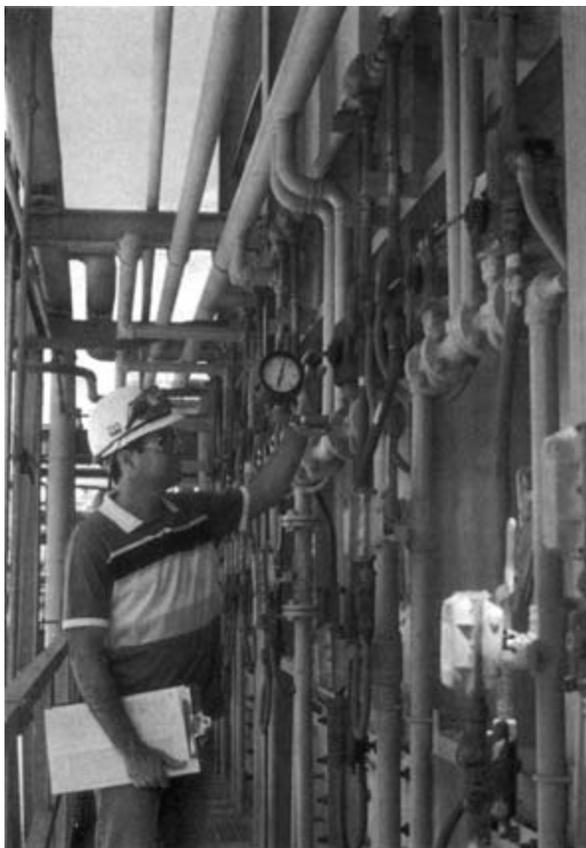
FIGURE 10–23 A chemical process operator relies on a furnace fuel shutdown system.

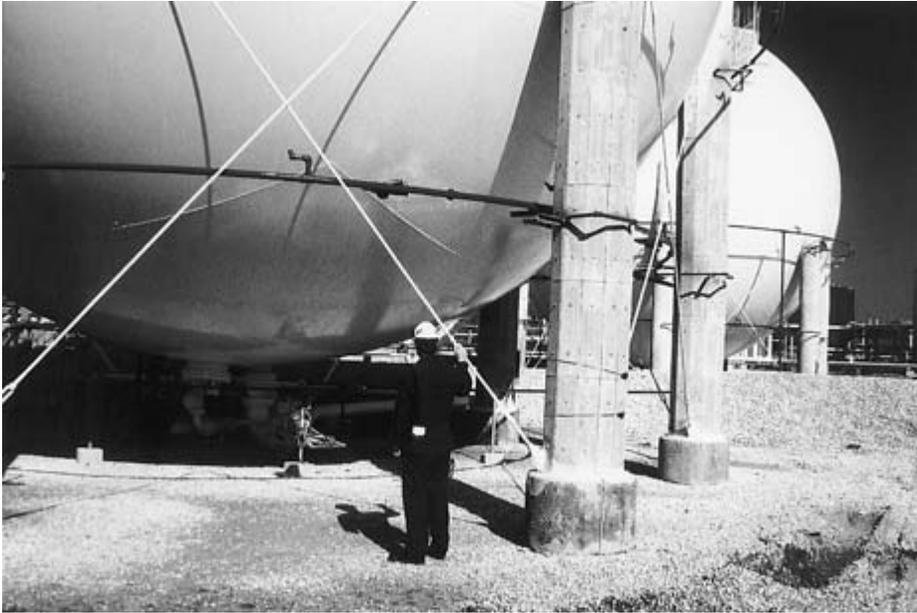
FIGURE 10-24 A chemical process operator witnesses the testing of an “Emergency Isolation Valve” below a sphere of flammable product.

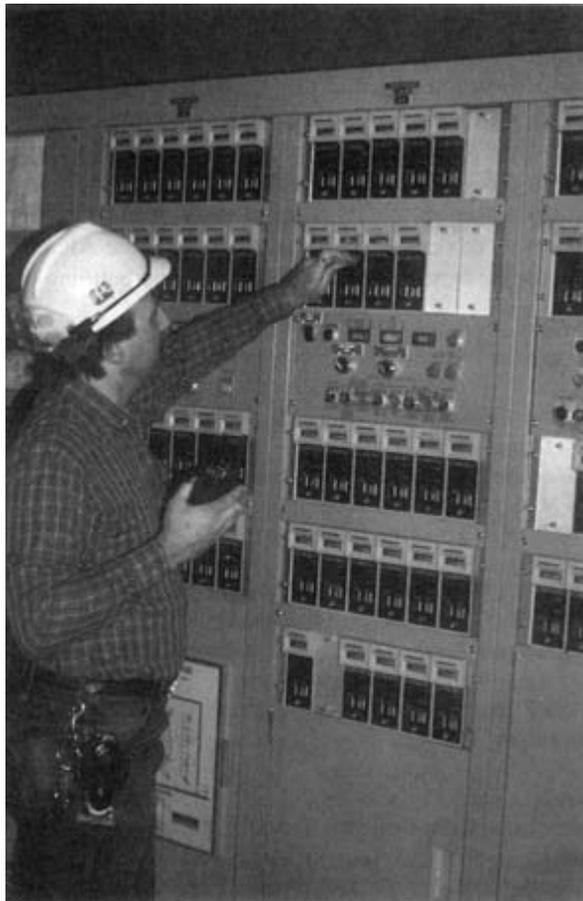
FIGURE 10-25 An instrument mechanic proof-tests a critical instrument panel.

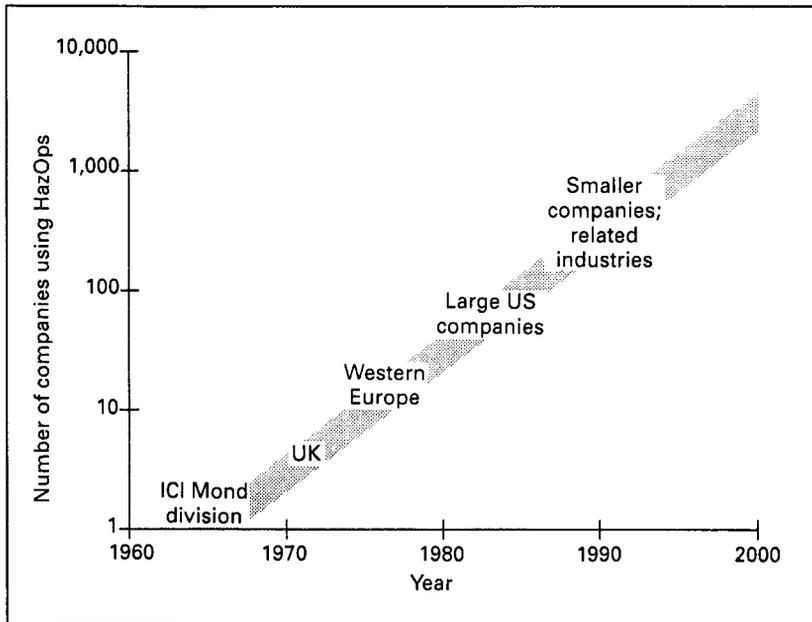
FIGURE 11-1 Estimate of the extent of HAZOP usage. Courtesy of R. W. Johnson, Battelle Memorial Institute.
