A NEW APPROACH TO DAMAGE DETECTION IN COMPOSITE BODY STRUCTURES USING TIME COMPENSATED HYPER SPECTRAL IMAGE ANALYSIS TECHNIQUE

Mahmoud Zaki Iskandarani

Department Computer Science, Faculty of Science and Information Technology,
Al-Zaytoonah University of Jordan, Post Code 11191, Amman, Jordan

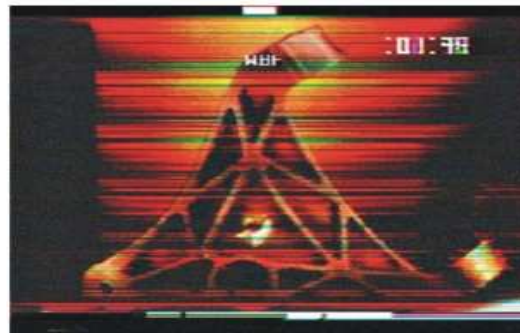
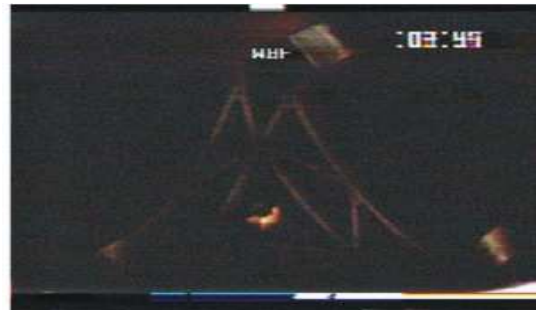
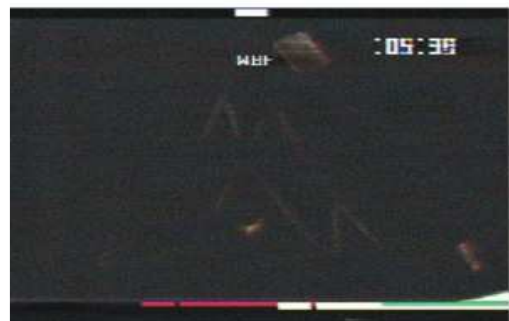
Fig. 2. Damaged Wishbone thermal image at 0 sec

Fig. 3. Damaged Wishbone thermal image at 0.59 sec

Fig. 4. Damaged Wishbone thermal image at 1.39 sec

Fig. 5. Damaged Wishbone thermal image at 3.49 sec

Fig. 6. Damaged Wishbone thermal image at 5.39 sec

Figure 2-6 show wishbone thermal images from a damaged side obtained using the setup in Fig. 1, while Fig. 7-9 present thermal images for the wishbone undamaged side.
